## **SURVEYS TO RECORD BAT ROOSTS IN STRUCTURES IN PHOENIX PARK**

### **PHASE 1 (2007)**

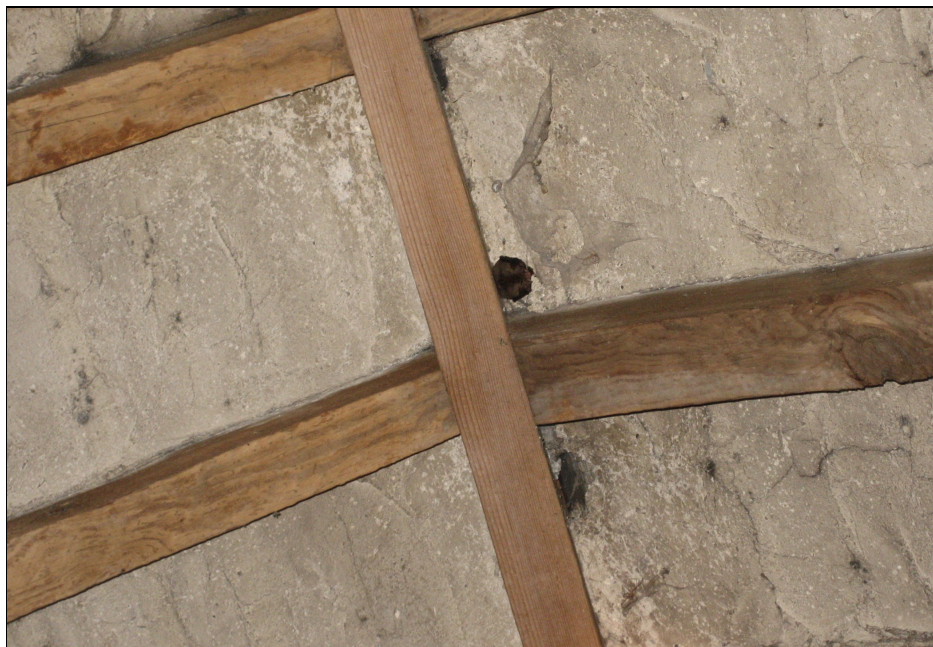
**Figure 2: Brown Long-eared Bat roosting on the ridge beam in the church in St Mary's Hospital, Phoenix Park.**

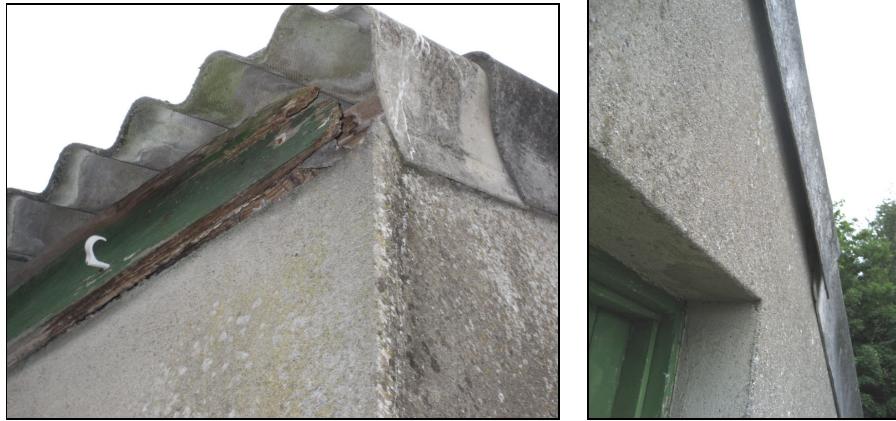
**Figure 3: Gaps under lead flashing and under soffit boards can provide access for bats (US Ambassador's Residence outbuildings, Phoenix Park)**

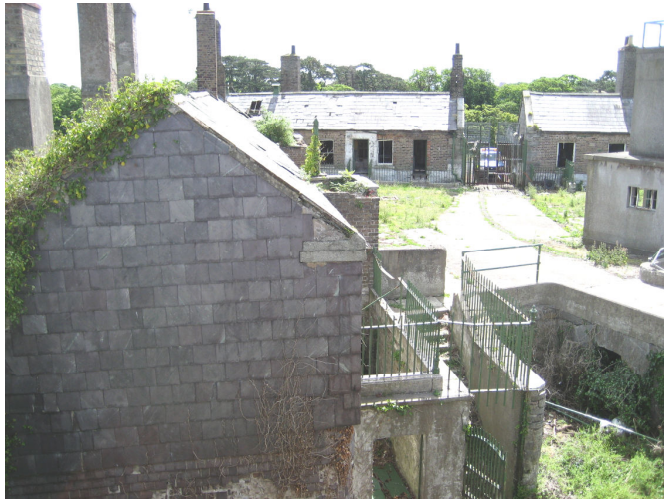
**Figure 4: Hanging slate tiles and old slate roofs provide excellent crevice roosts for Pipistrelle species and other small bats (Magazine Fort, Phoenix Park).**

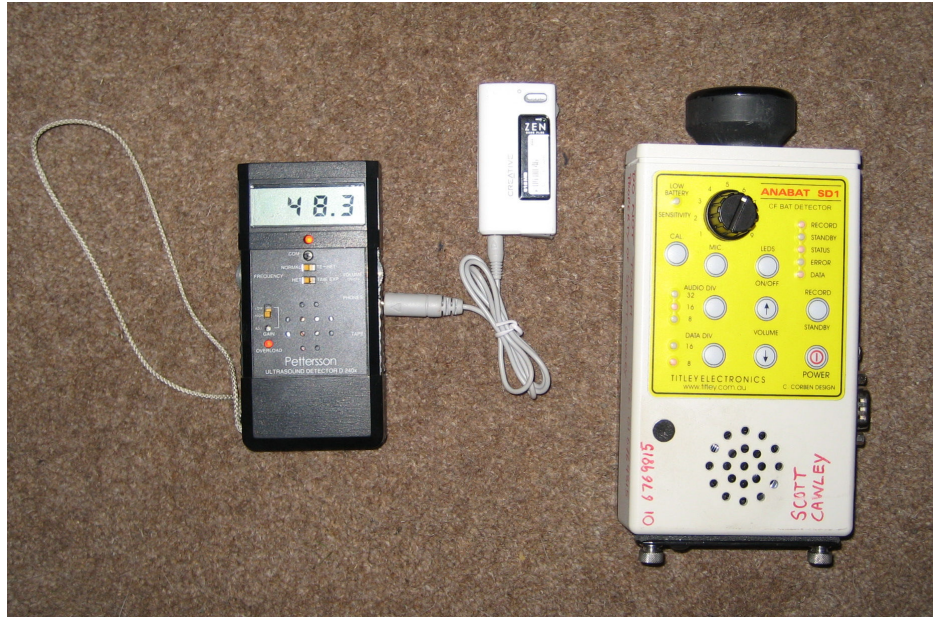
**Figure 6: Recording Equipment used during detector surveys (L-R Pettersson D240x Time Expansion detector linked to Creative Nano Plus Mp3 recorder, Anabat SD1 Bat detector)**

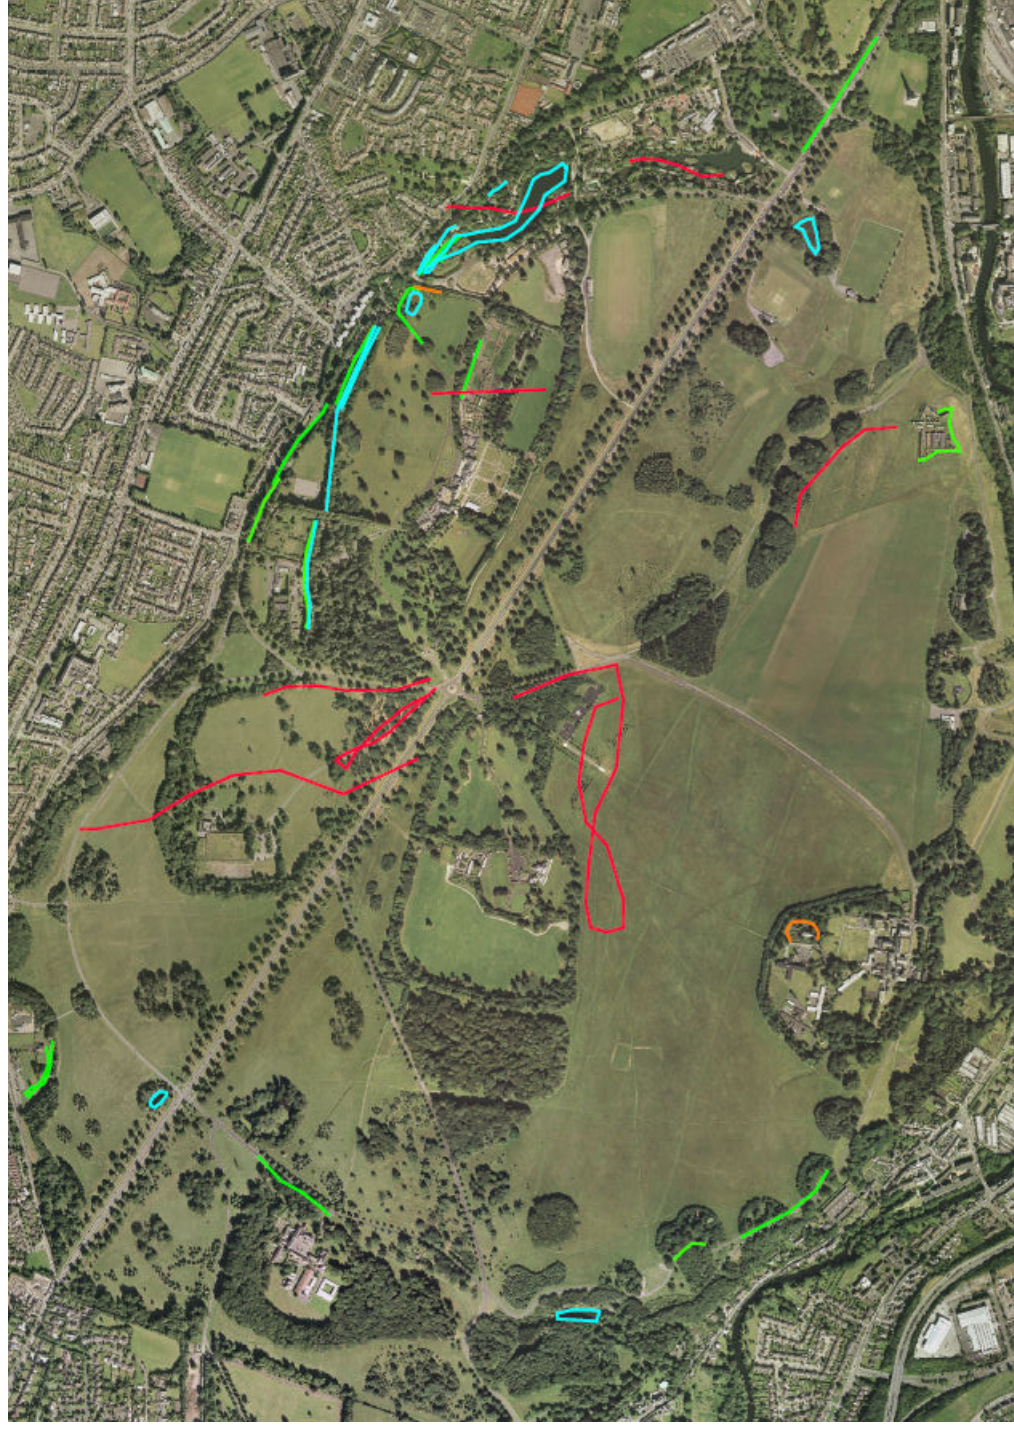
**Figure 7: Activity Bat  
Activity recorded around  
Phoenix Park 2007.**

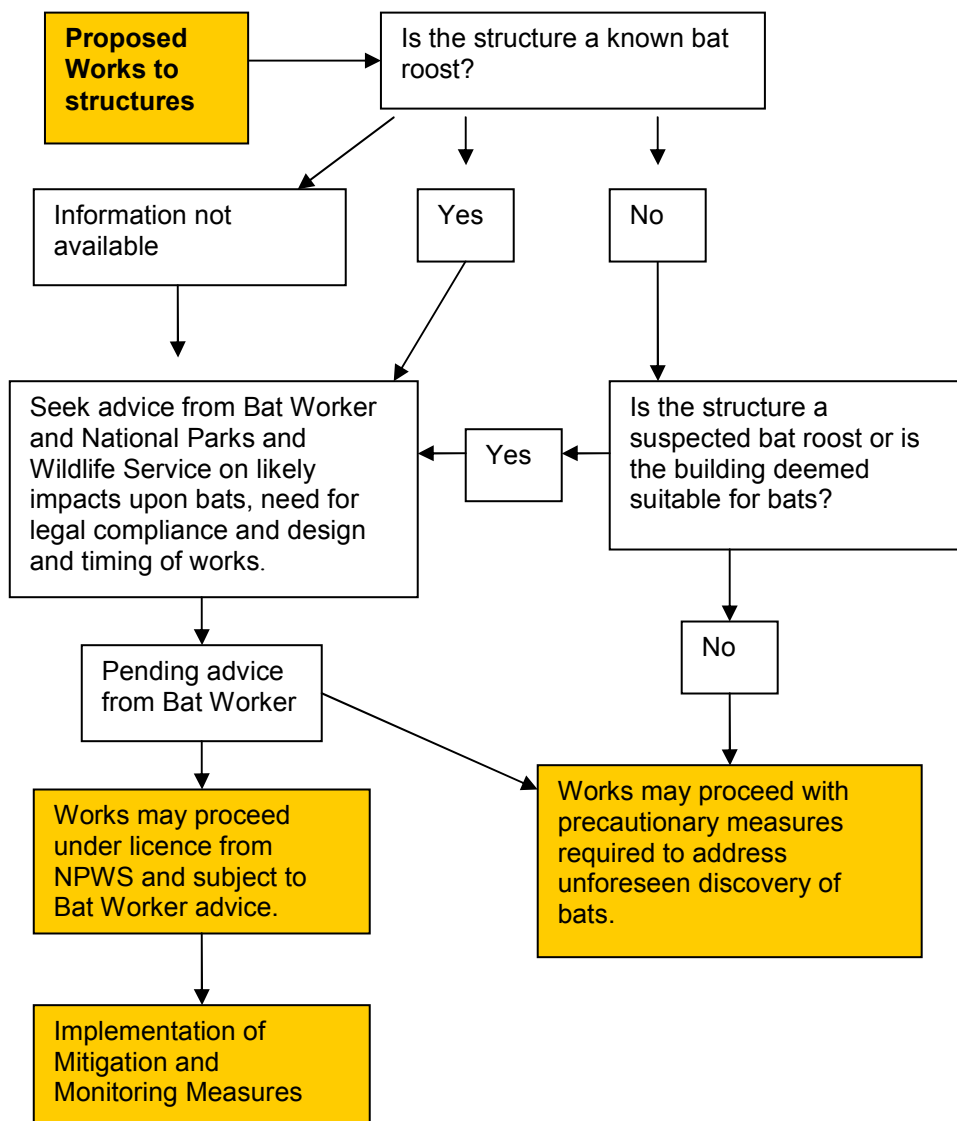
**Figure 8: Decision-tree for screening proposed works to structures in Phoenix Park.**

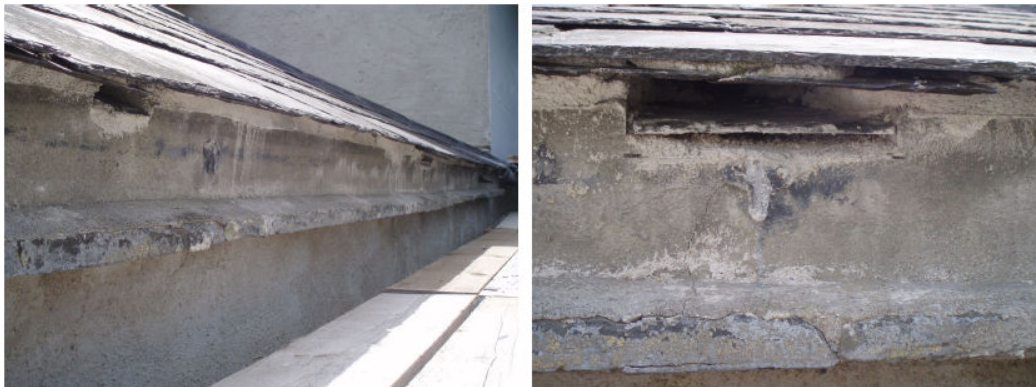
**Figure 9: Artificial roost access slits under eaves suitable for Pipistrelle species (Bishop's Palace, Kilkenny)**

- **Avoidance: E.g.**
  - Avoid the periods during the year when bats are most likely to be present and when the impact would be greater. E.g. works in cellars and underground sites are avoided in mid winter when bats hibernate.
  - Avoid areas where bats are roosting. E.g. bats roosting in one area of a roof may be temporarily 'sectioned off' in some circumstances to allow works to be carried out in another section of the roof.
  - Avoid use of chemicals known to be harmful to bats.
- **Minimisation: E.g.**
  - Minimise period of time spent near bats.
  - Minimise application of chemicals in bat roosts.
  - Minimise disturbance times and physical extent when they cannot be avoided.
- **Remediate/Compensate:**
  - Compensate for loss of former roost site by providing another in same location.
  - Provide artificial roost entry points: See Figure 9:

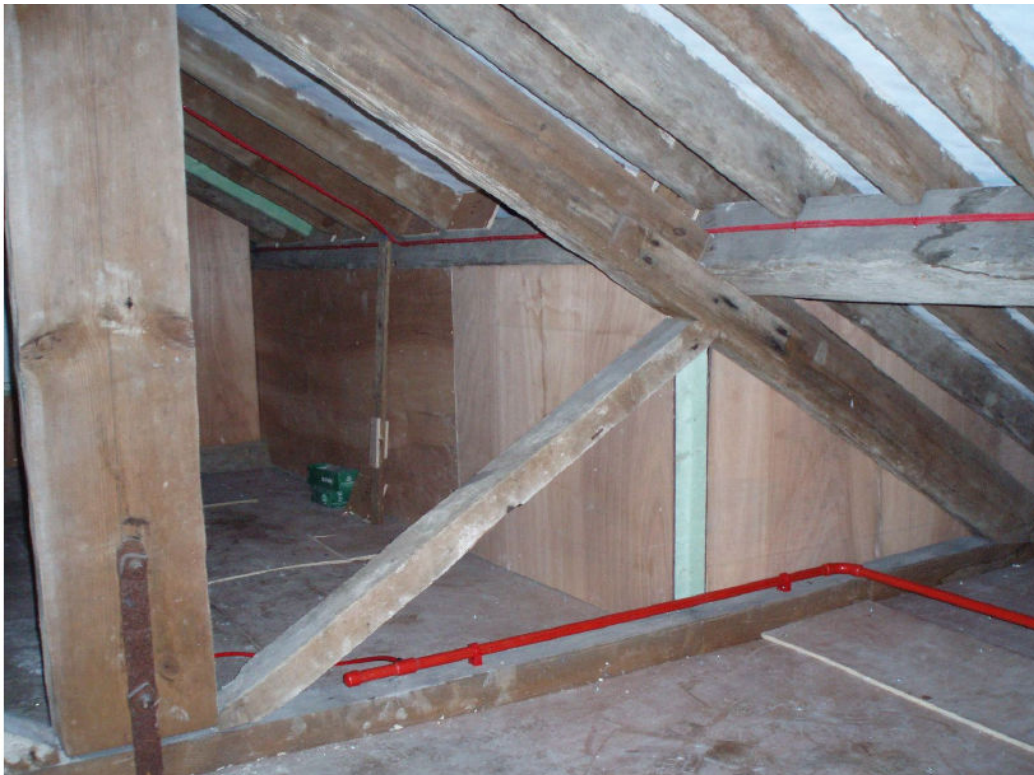
**Figure 10: Plywood walls of bat roost zone allowing bats to roost undisturbed (Bishop's Palace, Kilkenny)**

- Provide roosting zones where bats may roost and be controlled (e.g. removing droppings etc)

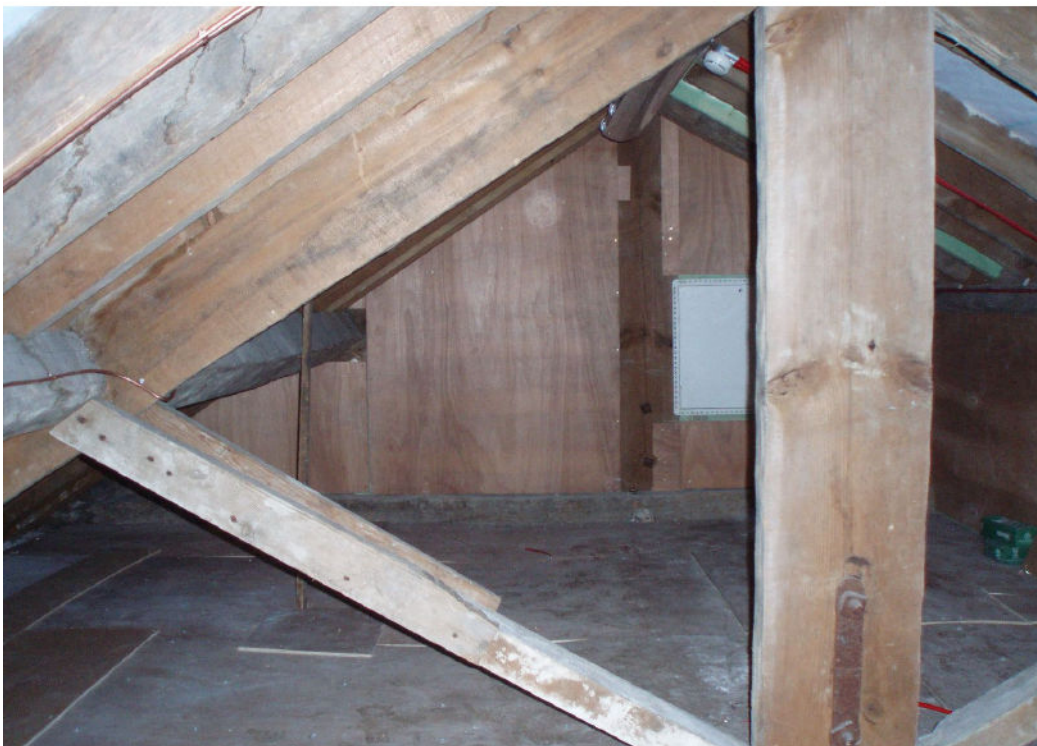
**Figure 11: Wall of bat roost zone with plastic access hatch (Bishop's Palace, Kilkenny)**

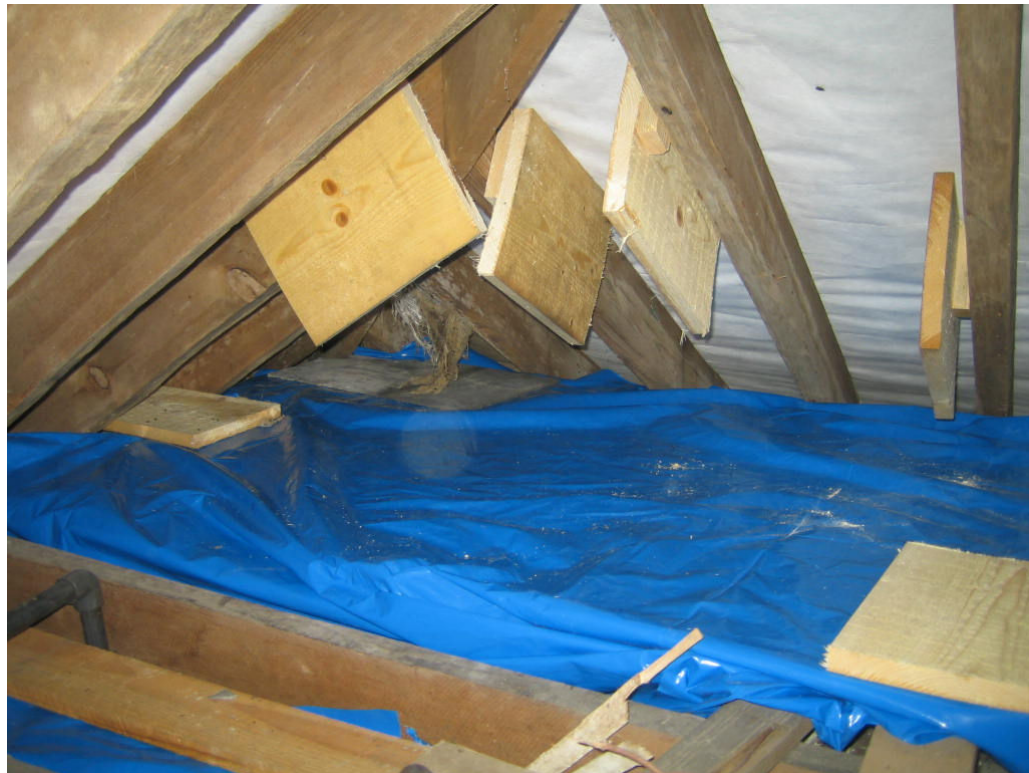
**Figure 12: Bat roost zone with plastic sheeting and roost boards to control roost area and allow collection of droppings (Emo Court, Co. Laois).**
