PONDS of the PHOENIX PARK

Current Ecological Status and Future Management

Caffrey, J.M., Coyne, J. & Gallagher, T.

February 2008

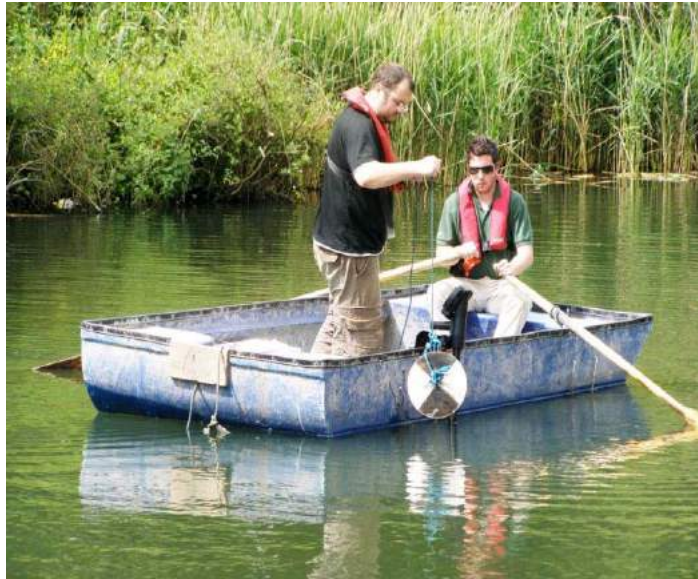
Bathymetric maps were produced for all of the ponds surveyed. Water depth readings used in the production of the maps were collected using a depth finder (Fishin Buddy[™] 1200) (Plate 2). GPS co-ordinates were recorded concurrently and maps were produced using GIS ARCVIEW 9.2[™].

Plate 2. A Secchi disc being used to determine water clarity. The depth finder (Fishin Buddy[™] 1200) can be seen on the boat. People's Garden Pond, Phoenix Park.

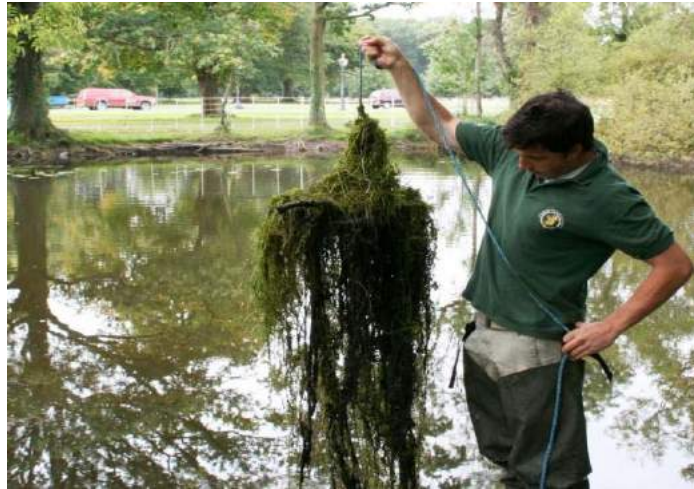
Aquatic vegetation was recorded in the following categories: emergent, floating-leaved, free floating, submerged and filamentous algae. An eight-pronged grapnel was used to retrieve submerged vegetation in each pond (Plate 3). The majority of species were identified on site. Those species that required more detailed examination were returned to the laboratory for identification.

**Plate 3. Sampling aquatic vegetation using an eight-pronged grapnel.
In the background is the Machine Pond,
near the Castleknock exit of the Phoenix Park.**

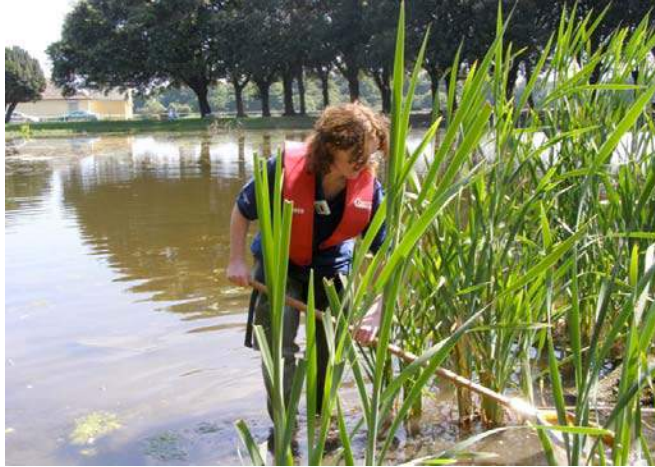
Sampling of macroinvertebrates involved an initial walkover survey to identify the various mesohabitats in each pond. A variety of mesohabitats were identified in the Phoenix Park ponds. These included exposed sediments, stands of emergent reeds and areas of submerged or floating-leaved aquatic plants. Macroinvertebrates were collected by continuously sweeping a handnet for a total of 3 minutes through the habitat being sampled (Plate 4). The three minutes of sampling was divided equally between the various mesohabitats that were identified during the walkover survey.

Plate 4. Invertebrate sampling using a sweep net in reed beds (*Typha latifolia*) of the Dog Pond, Phoenix Park.

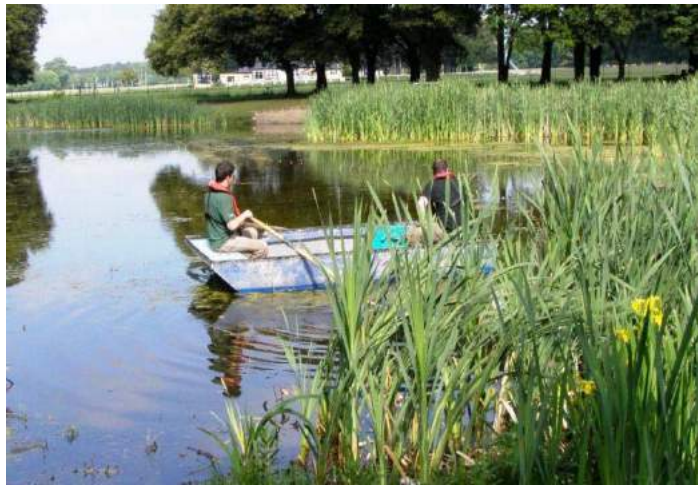
Plate 5. Setting fyke nets in the Dog Pond, Phoenix Park.

Netting methods included the use of multimesh (monofilament) gill nets and conical “Dutch” fyke nets (Plate 5). It is normally desirable to fish nets for a 24 hour period (Caffrey, 2002), including periods of day and night. However, on the recommendation of

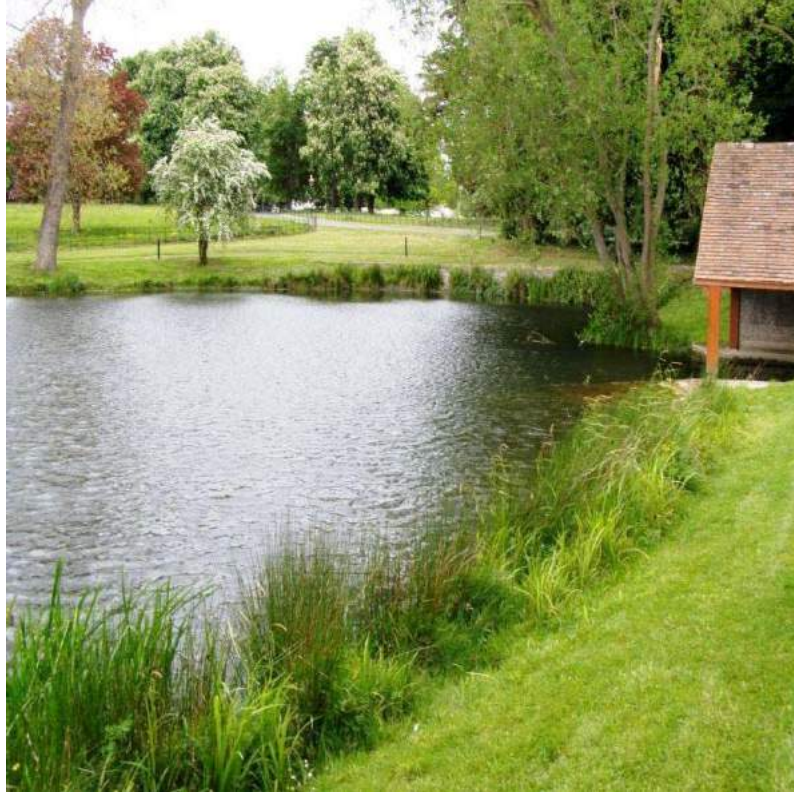
Plate 6. The Áras Pond, in Áras an Uachtaráin, Phoenix Park, showing the boathouse to the right of the pond.

The Áras Pond is *circa* 0.28 hectares in area and is roughly circular in shape. The pond has an on-line design, which incorporates both an inflow and outflow. Structures associated with the pond include a stone wall to support the inflow and a large dam constructed from boulder and rock at its eastern end. The northern and southern shores are lined with marginal vegetation (Plate 6).

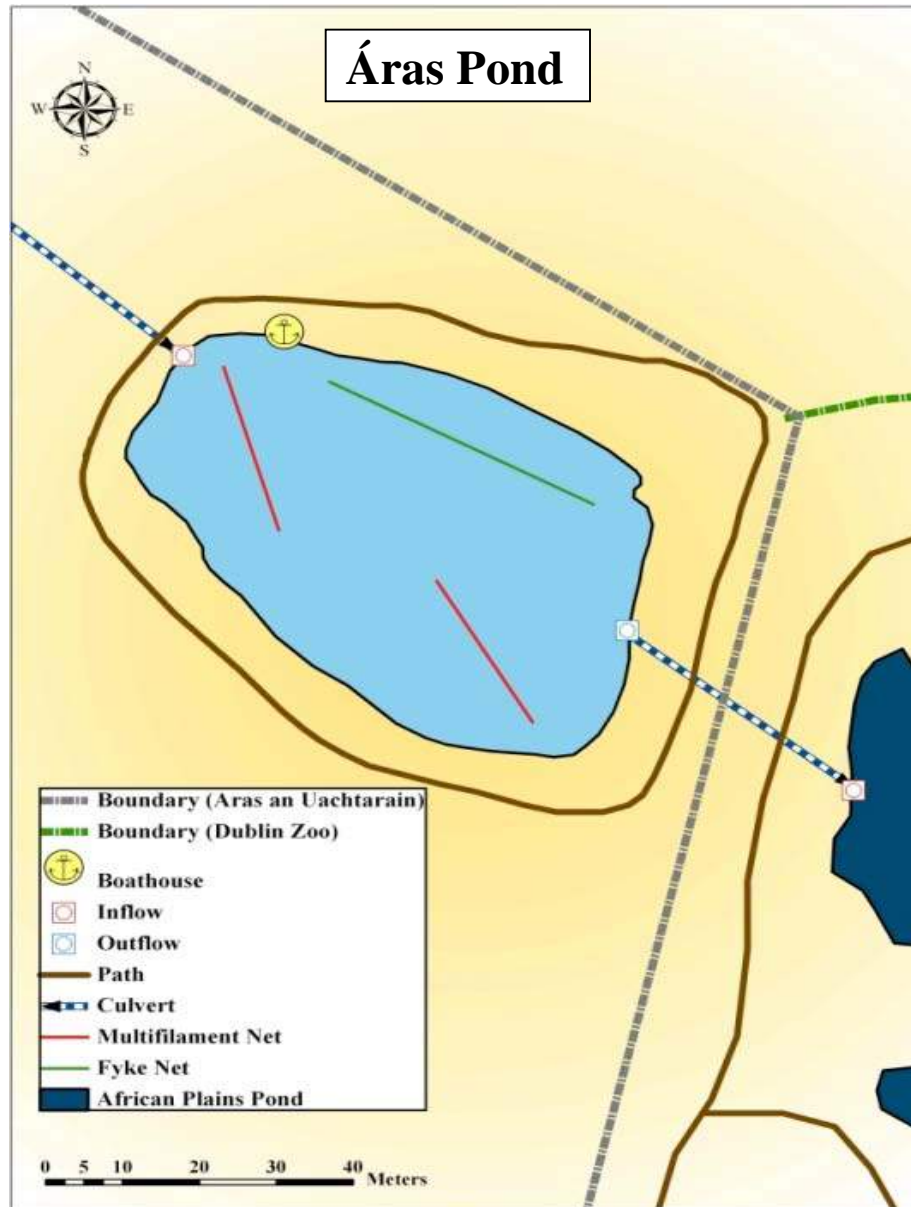
It is the first of four ponds on this watercourse, which eventually discharges to the River Liffey (see Figure 1). The outflow is located at the south-eastern end of the pond (Figure 2). Water is discharged from the pond in a south-easterly direction through two large (15-20”) pipes for c. 60m to the African Plains Pond in the Dublin Zoo complex (Figure 2). At the time of sampling, the flow into the Áras Pond was negligible.

Figure 2. Map of the Áras Pond, Áras an Uachtaráin, Phoenix Park. The African Plains Pond is situated to the southeast, within the Dublin Zoo complex.

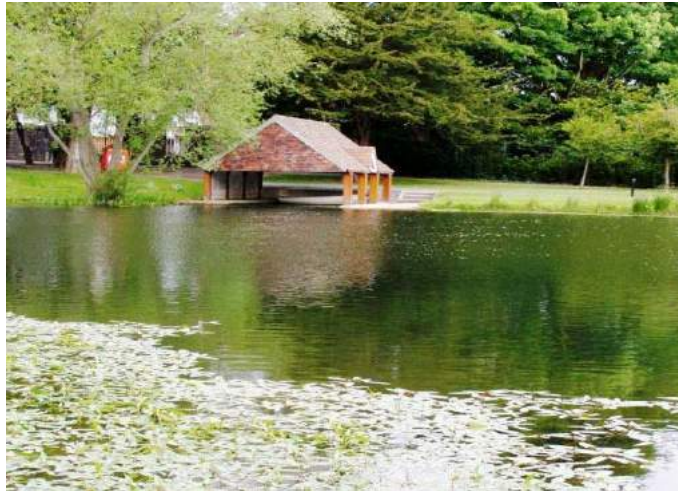
Plate 7. The boathouse on Áras Pond, Áras an Uachtaráin, Phoenix Park. A floating carpet of Amphibious bistort (*Polygonum amphibium*) borders the pond margin in the foreground.

Beyond the emergent vegetation zone, isolated and often large stands of the floating-leaved Amphibious bistort (*Polygonum amphibium*) were present (see Plate 7). Most prominent among the submerged species were Water starwort (*Callitriche* sp. (cf. *hermaphroditica*), Fan-leaved crowfoot (*Ranunculus circinatus*) and filamentous green algae. The starwort formed loose and often straggling cushions of light-green vegetation while the stands of crowfoot were relatively inconspicuous on the pond bed. The filamentous algae, comprising mainly *Cladophora* sp. (cf. *glomerata*) and lesser stands of *Spirogyra intestinalis*, dominated the submerged flora. These algae carpeted *circa* 60% of the pond bed and generated surface scums during the autumn months (see Plate 12). A proliferation of filamentous algae is commonly suggestive of organic enrichment but, in the case of this pond, it may be more an indicator of stagnant water conditions following a period of low rainfall.

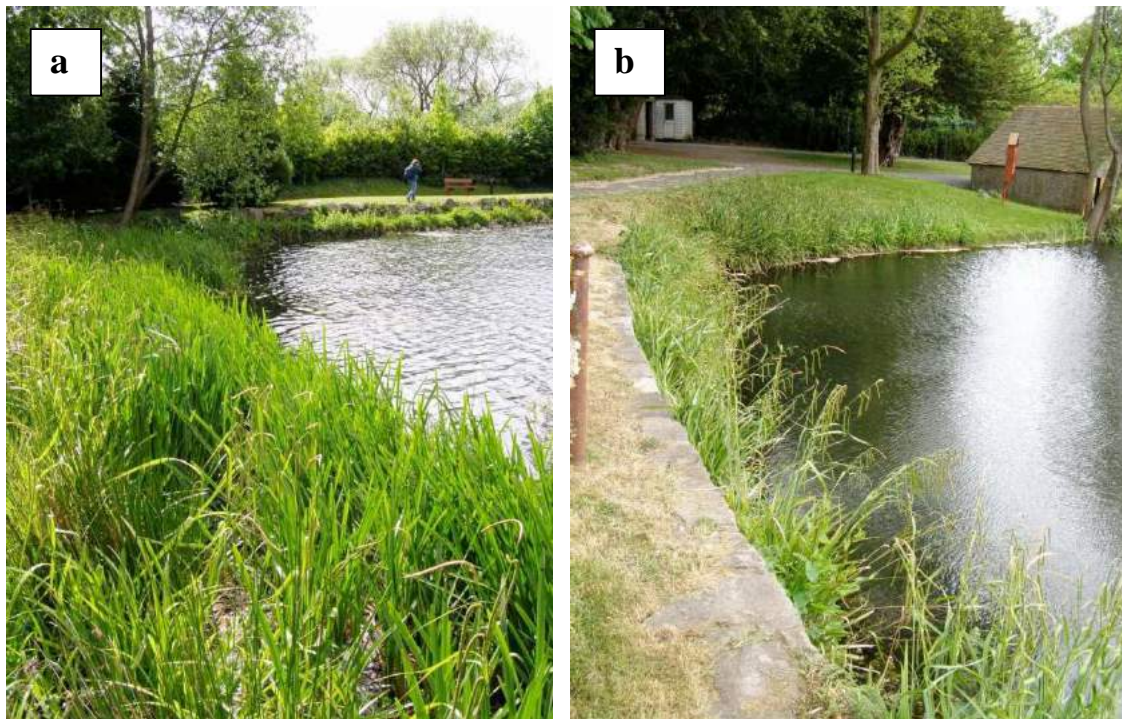
An abundant and relatively diverse aquatic macrophyte flora occupied the Áras Pond and its relatively steep margins. Seventeen species were recorded in total (Appendix II). Most of the marginal pond area was vegetated with emergent plants, the most prolific of which were Branched Burreed (*Sparganium erectum*), Water Mint (*Mentha aquatica*), Reed sweet-grass (*Glyceria maxima*), Yellow flag (*Iris pseudacorus*) and Reedmace (*Typha latifolia*). This vegetation maintained a relatively low profile around most of the pond, although occasional tall stands were present (Plate 8). In places, the emergent stands encroached into the pond, occasionally to a depth of 0.4m.

Plate 8. Marginal aquatic plant communities on a) the northern shore and b) the western shore of the Áras Pond, Áras an Uachtaráin, Phoenix Park in 2007. The wall protecting the inflow to the pond and the boathouse on the north-western shore can be seen in the background (b).

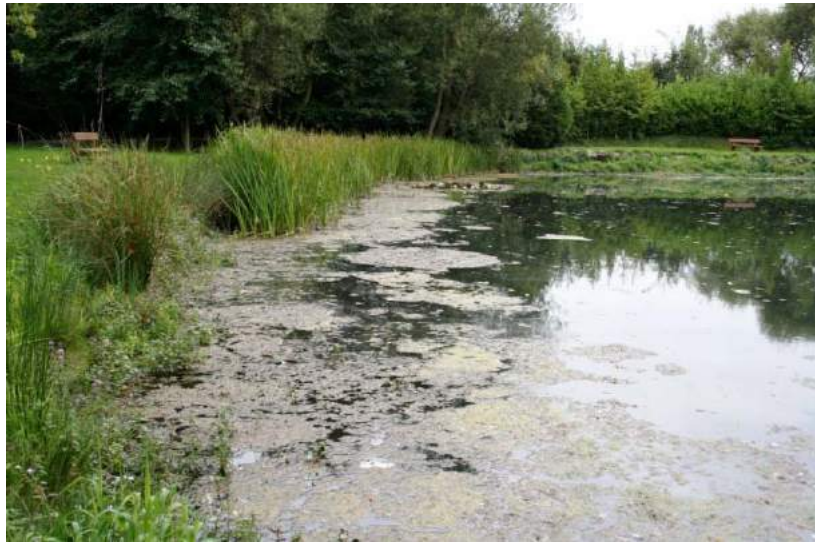
Plate 11. Presence of filamentous algae bloom in Áras Pond, Áras an Uachtaráin, during October 2007.

The main priority of the Áras Pond is to provide a visual amenity on the grounds of Áras an Uachtaráin for its residents and visitors. Therefore, one objective may be to reduce the level of unsightly filamentous algae that is present in the pond at certain times of the year (Plate 11). This not only affects the aesthetic value of the pond but can result in serious diurnal fluctuations in dissolved oxygen levels (Caffrey, 1992). These fluctuations can be sufficient, particularly during warm weather, to cause fish kills. One environmentally-friendly method that has proved effective for the control of filamentous algae in freshwaters is the use of rotted barley straw (Caffrey, 1999). The rotted straw has strong anti-algal properties. It is recommended to apply the straw at a rate of 10gm^{-3} (Barrett & Banks, 1995; Ridge *et al.*, 1995; Caffrey, 1999) in the open water column, packed relatively loosely in garden netting to allow the straw to rot quickly and aerobically (Barret *et al.*, 1996).

The straw should be introduced to the pond in winter, when no algae are present in the water. The straw must be replaced every 4 to 6 months, depending on the rate of decay. The removal of the filamentous algae would improve the aesthetics of the pond by increasing water clarity, as well as providing conditions that would favour the establishment of diverse plant and faunal communities. This, in turn, would provide a more diverse habitat for the fish stock within the pond, increasing the level of cover from avian predators, such as herons and cormorants, and creating spawning substrate and refuge for juvenile fish stocks.

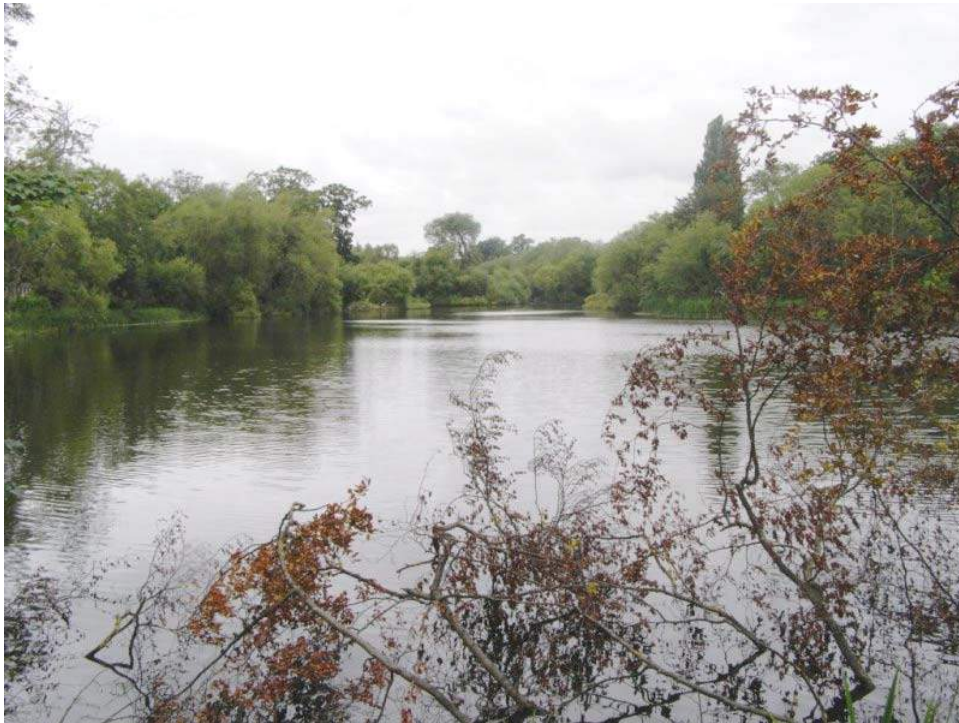
Plate 13. The African Plains Pond, Dublin Zoo, Phoenix Park.

At *circa* 2.6 hectares, the African Plains Pond is the largest water body in the Phoenix Park. It is an S-shaped on-line pond, with one island and a peninsula located at its

northern end (Figure 6 and Plate 13). The latter, the chimpanzee complex, was constructed in 1997 to provide more space for the apes during daylight hours. The island is used to accommodate a mangamese monkey population, with bridged access to an indoor shelter on the eastern side of the pond.

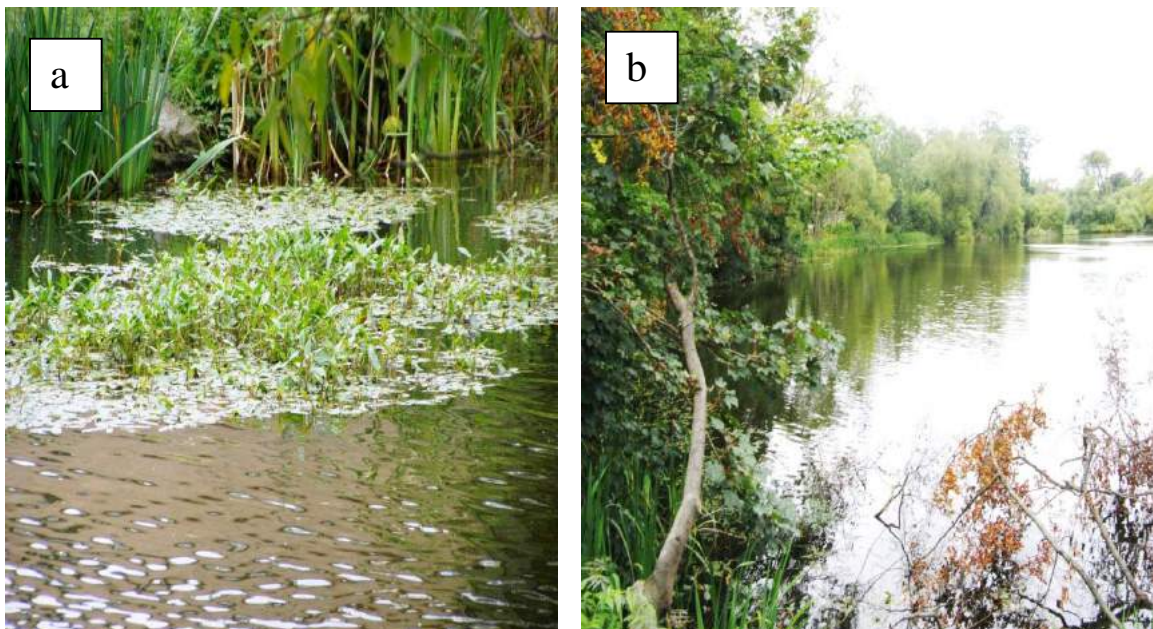
Polygonum amphibium was the principle floating-leaved macrophyte species recorded in the pond. This species presented localised but dense floating rafts of vegetation, primarily in the channel adjacent to the newly created chimpanzee peninsula (Plate 14a).

Plate 14. Marginal and floating-leaved aquatic plant communities on a) the northern and b) the southern shore of the African Plains Pond in Dublin Zoo.

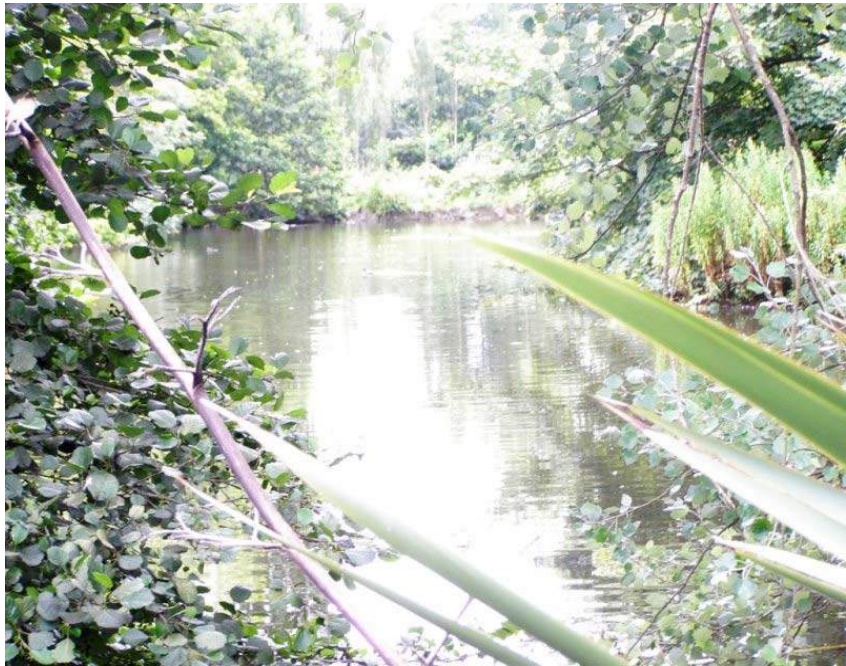
Plate 17. Upper World of Primates Pond, Dublin Zoo, Phoenix Park.

The third pond in System A is known as the Upper World of Primates Pond. A small, rectangular-shaped pond, it is situated downstream of the African Plains Pond (see Figure 1) and within the Dublin Zoo complex. It is connected *via* the Viceregal Stream to the African Plains Pond through an underground culvert, which enters at its northern end (Figure 9). It is directly linked to the larger Lower World of Primates Pond through a 10m-long and 3m-wide open channel at its southern end (Figure 9). This channel is crossed by a bridge, which incorporates a pedestrian path for zoo patrons. Water flow was negligible during the survey, possibly due to the extremely dry conditions experienced in October 2007. A large volume of leaf litter was evident on the pond floor.

At *circa* 2500m², the Upper World of Primates Pond is the smallest water body in the entire park system. It contains three small islands, and the banks are formed by a concrete apron.

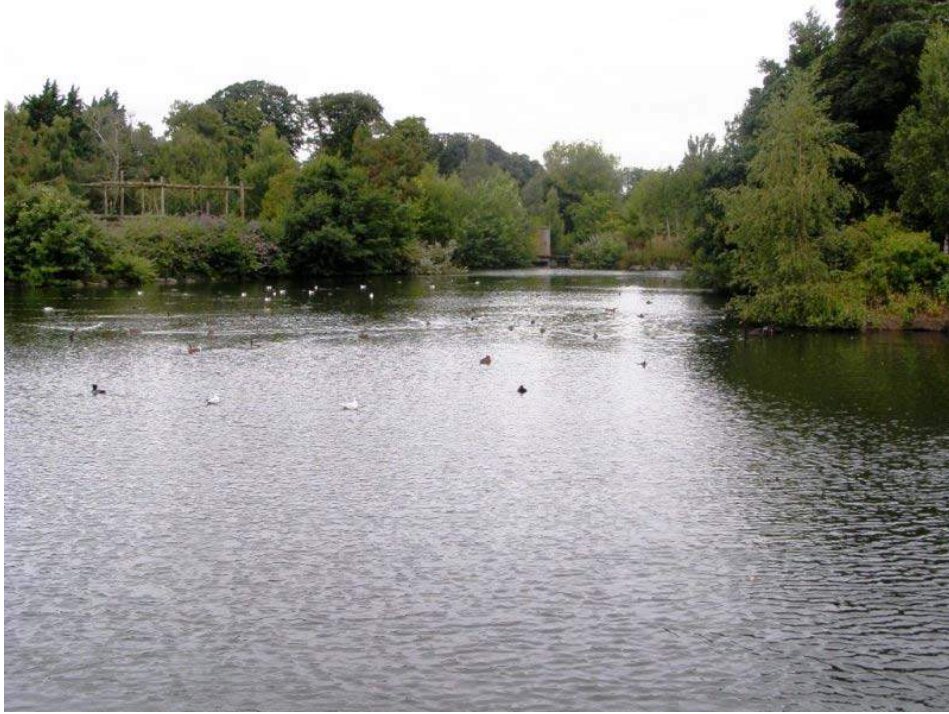
Plate 18. A view of the Lower World of Primates Pond in Dublin Zoo from the boardwalk, looking towards the northern end of the pond.

The pond has been a part of the Zoological Gardens since its inception in 1831. It has undergone major modifications since 1997 when, in order to house a number of primate species, a series of islands and an artificial peninsula (Figure 10) were constructed. A large rectangular-shaped water, it now occupies an area of *circa* 1.2 hectares.

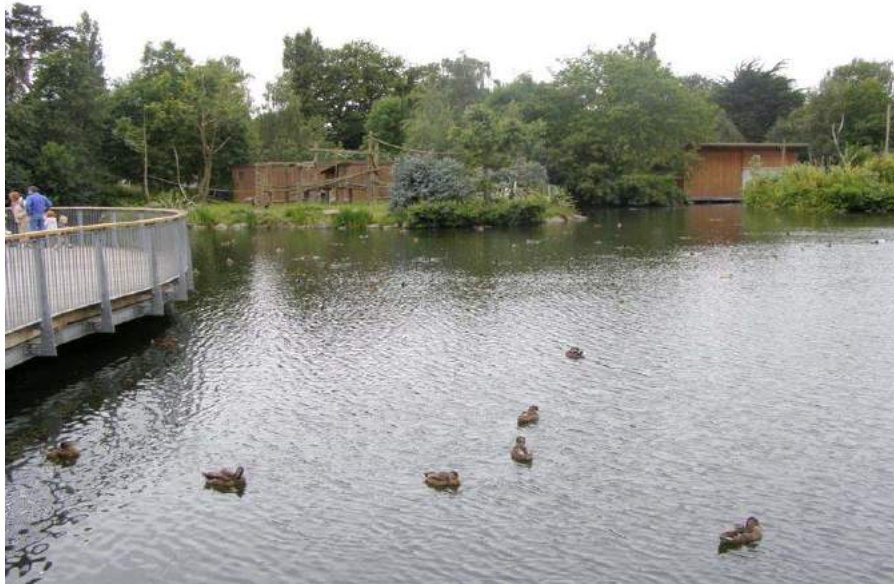
Plate 19. The Lower World of Primates Pond, Dublin Zoo. The Boardwalk at the entrance to the Dublin Zoo can be observed to the left.

The entire pond is encircled by walkways (Figure 10). These lead to and from the main entrance, the animal enclosures and the seating areas. Between the paths and the pond, the eastern and northern banks are dominated by large trees, which overhang the banks of the pond. The western shore is lined by indoor primate enclosures. These are connected to the four islands *via* walkways for the primate's daily use.

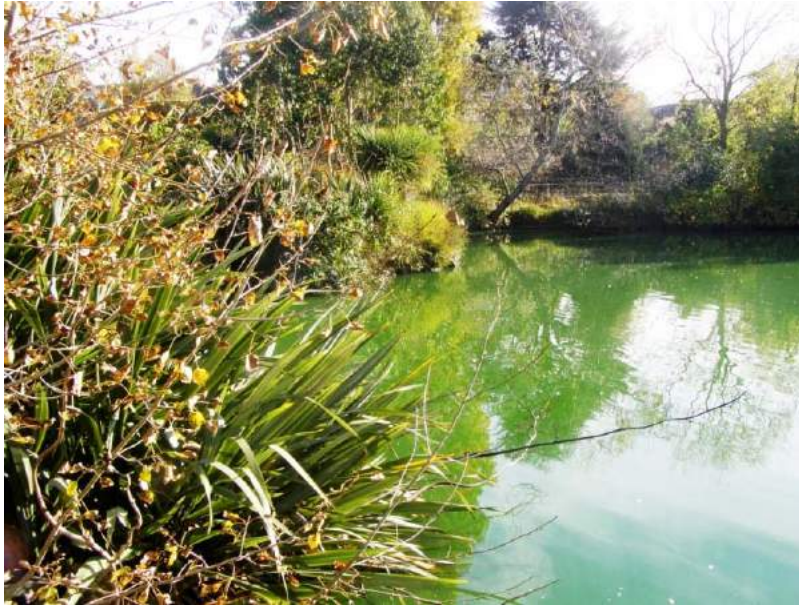
**Plate 21. Lower World of Primates Pond, Dublin Zoo, Phoenix Park in October 2007.
The extent of the algae bloom can be clearly seen.**

Results of water quality analysis on the Upper and Lower World of Primate Ponds revealed highly eutrophic conditions. The flamingo enclosure is contributing to significant nutrient loading, the outcome of which was visually apparent in the dense phytoplankton bloom in the lower pond at the time of sampling. This eutrophic state has significant repercussions for the overall ecology of the pond and its ability to sustain healthy floral and faunal communities, in addition to the impact on the aesthetic appeal of the water body.

planktonic growth, while also creating a healthier and more ecologically sustainable habitat for resident biotic communities. Dredging may be conducted in the traditional manner, where the pond must be dried out and the silt removed using heavy plant machinery, or using an innovative method where the minimum of habitat disturbance is caused. This latter method involves using a sweep-back slurry-type pump, on a raft, to remove the mud from the pond and pump it into large geotextile tubes, which are situated on the bank side. Over a period of weeks, the water drains through the geotextile lining to leave relatively dry silt that may be used for other purposes elsewhere in the park.

In order to immediately tackle the problem, while considering a more long-term solution, barley straw could be introduced into the ponds. Rotted straw has the ability to control filamentous and planktonic algae growth through its anti-algal properties (Caffrey, 1999). It is recommended that barley straw be introduced at a rate of 10g m^{-3} or 100 kg acre^{-1} ,

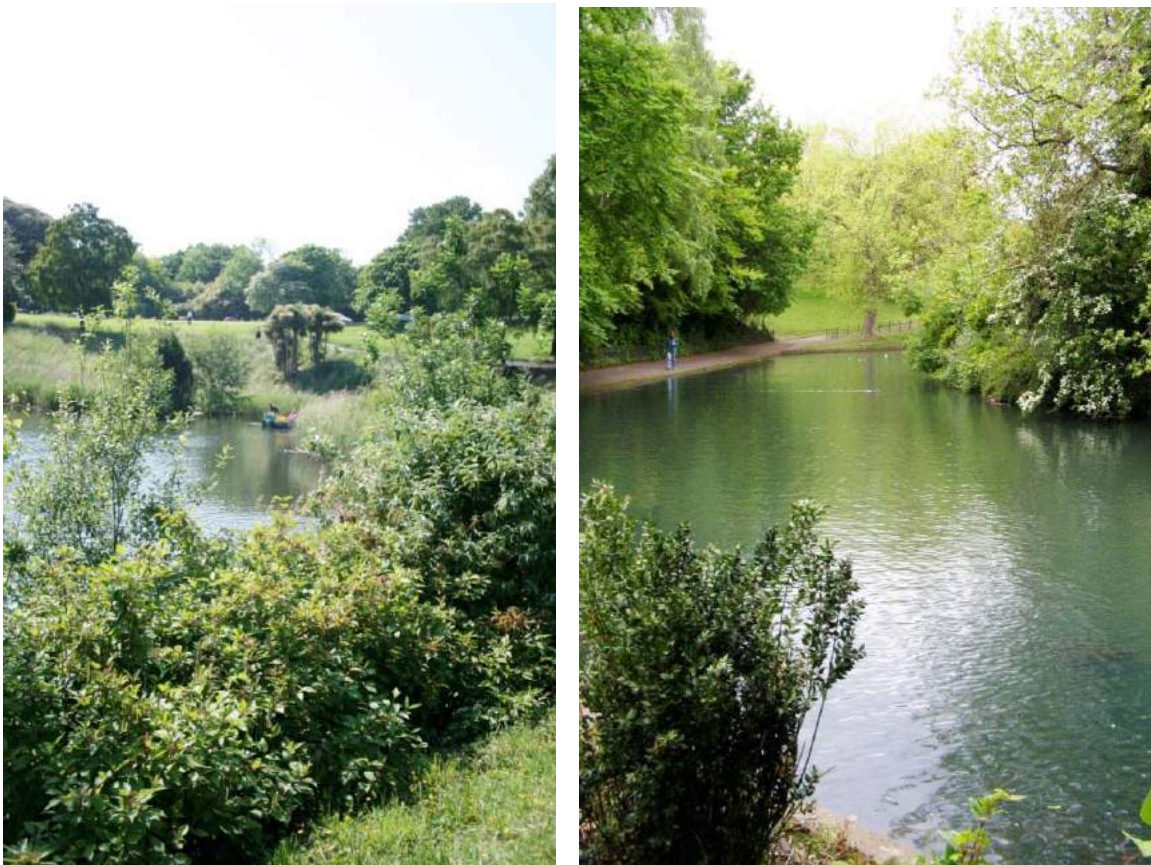
Plate 25. Views of the upper section of the People’s Garden Pond in the Phoenix Park.

Created as part of the famous People’s Garden in 1864 (OPW, 1993), this is one of the larger ponds in the Phoenix Park, occupying an area of *circa* 0.8 hectares. It is fed entirely by the discharge from the Lower World of Primates Pond in the Dublin Zoo complex. The pond is located in a deep depression known as the “hollow” (Davenport & Hughes, 2004) in the south-eastern corner of the Phoenix Park (Plate 25, see Figure 1). This is the fifth and last pond on the Viceregal Stream that passes through the Áras Pond and through the three ponds located within Dublin Zoo. From the People’s Garden Pond the water discharges into the River Liffey, some 1.2 km to the south (Figure 16). The pond is situated in a busy section of the park, between the Islandbridge and North Circular Road entrances (see Figure 1).

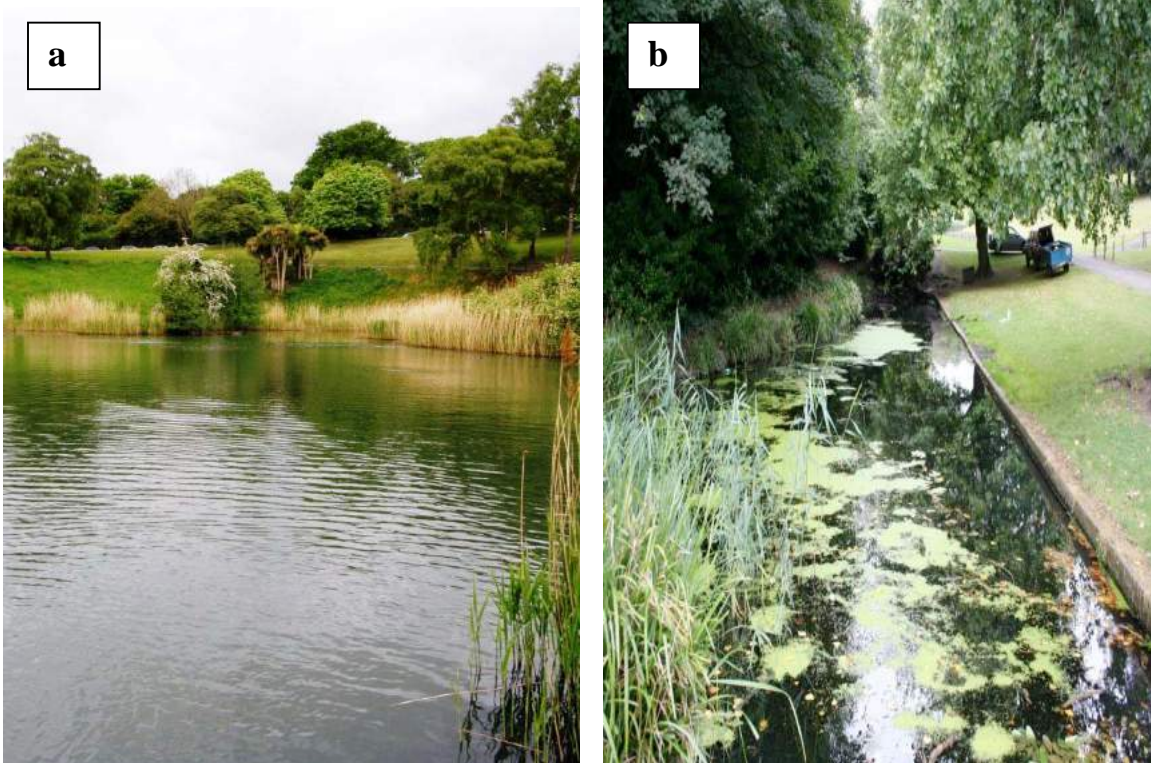
Plate 26. The (a) upper and (b) lower sections of the People's Garden Pond, Phoenix Park.

The pond has two sections, a larger upper and a smaller lower pond (Figure 16). The latter simply represents an expanded outflow channel, with a concrete bed and sides. This small pond is tree-lined on its southern bank and bordered by a pathway on its northern bank. It is densely shaded by the overhanging tree canopy and this contributes to a deep layer of leaf litter on the pond floor. The perimeter is entirely concrete based and supports practically no marginal plant growth. A bridge separates the upper from the lower sections.

The margins of the upper section are largely natural and are densely reed fringed (Plate 26 a). The reed beds add character to the pond and provide a myriad of habitat niches for waterfowl and other wildlife. The perimeter at the eastern end of this pond, in the vicinity of the island, is a concrete structure and supports practically no marginal flora.

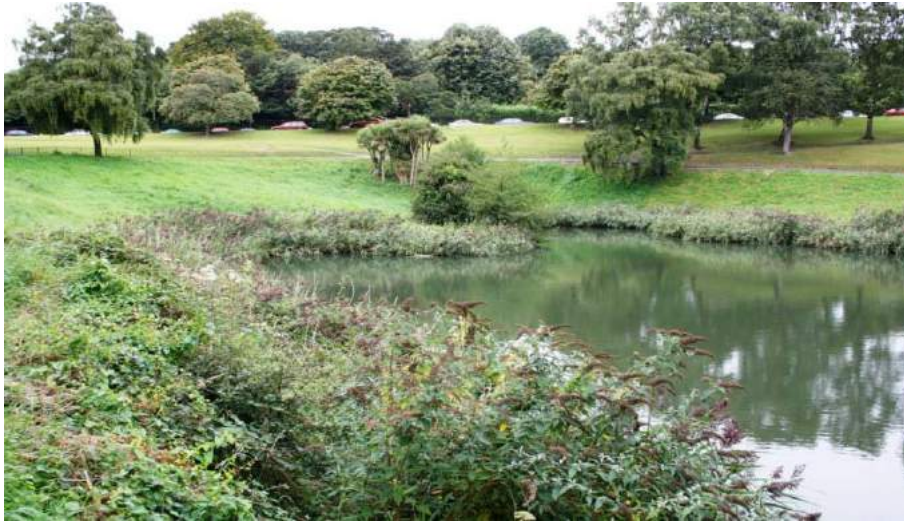
Plate 27. Marginal vegetation communities, dominated by *Phragmites australis*, in the upper section of the People's Garden Pond, Phoenix Park, in June 2007.

The marginal zone in the upper section of the People's Garden Pond was dominated by tall, virtually continuous stands of Common reed (*Phragmites australis*). This tall reed occupied *circa* 70% of the marginal area in this pond and dense stands

extended up to 5m into the water, often to a depth of 1.5m (Plate 27). Occasional, small stands of Sedge (*Carex* spp.) were present in marginal zones where *Phragmites* stands had been removed or disturbed. Small stands of the floating-leaved Yellow water-lily (*Nuphar lutea*) were present in the upper pond. It is probable that these stands will expand to occupy significantly more surface cover, if the pond remains undisturbed. The free floating species Common duckweed (*Lemna minor*) and Ivy-leaved duckweed (*L. trisulca*) were present with low abundance in the upper pond.

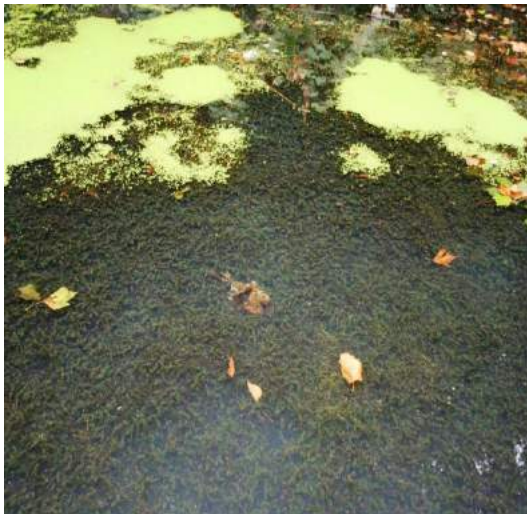
Plate 28. Dense submerged *Elodea canadensis* and free floating *Lemna minor* in the lower section of the People's Garden Pond, Phoenix Park, in June 2007.

The most abundant submerged macrophyte in the pond was Canadian pondweed (*Elodea Canadensis*), a plant that is tolerant of nutrient-rich conditions and thrives in waters that receive periodic disturbance. Its abundant vegetative expression here might reflect the occasional dredging or pond maintenance that this watercourse has been subjected to in recent years.

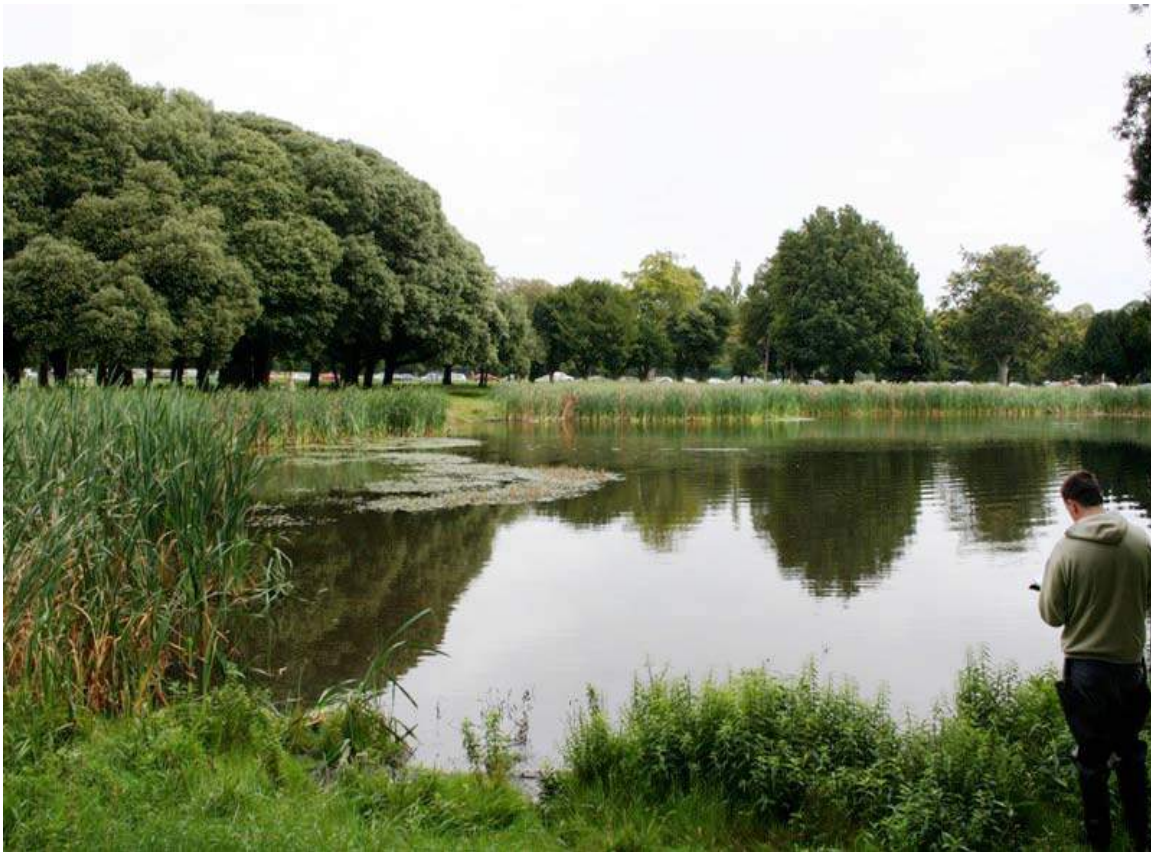
Plate 32. A view of the Dog Pond, Phoenix Park, from the western shore. Traffic on Chesterfield Avenue can be seen in the background.

The Dog Pond, also known as the Citadel Pond, is situated in the southeast section of the Phoenix Park (see Figure 1). It is located to the west of Chesterfield Avenue, the main road that cuts through the park (Plate 32), and is situated to the east of the Phoenix Park cricket grounds and pavilion. Approximately 0.4 hectares in size, this pond is roughly rectangular in shape.

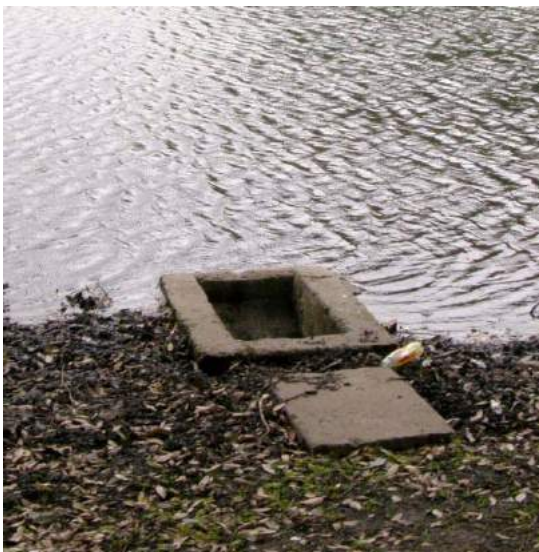
Plate 33. Constructed “monk” outflow on the Dog Pond, Phoenix Park.

No water inflow to the Dog Pond was located during the survey. Nor was reference made to an inflow stream or culvert in the available literature. An outflow “monk” is present at the south-western end of the pond (Plate 33). At the time of the survey, the water level was below the overflow spill.

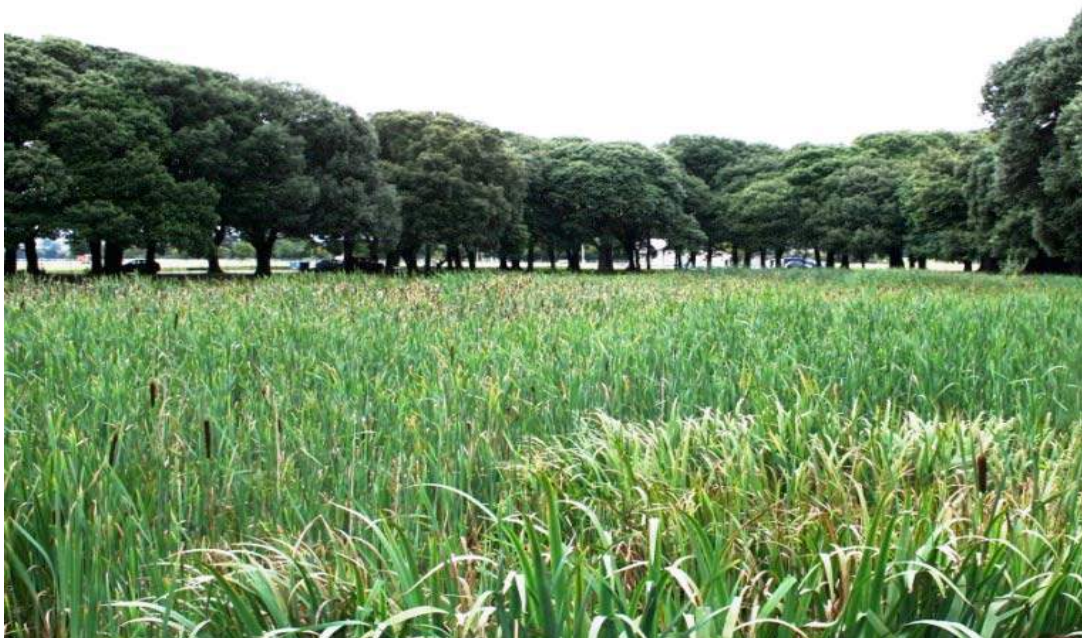
Plate 34. Extensive stands of Reedmace (*Typha latifolia*) in the Dog Pond, Phoenix Park, in 2007.

Tall marginal reeds (*Typha latifolia*) dominated the macrophyte flora of the Dog Pond (Plates 34 & 35a). The reed beds were virtually monospecific and encroached into the water for distances up to 15m. It is estimated that these reed beds occupied up to 35% of

the original pond area. Lesser stands of Reed canary grass (*Phalaris arundinacea*) and Yellow flag (*Iris pseudacorus*) were present at the margins of the dense *Typha* beds. The southern bank of the pond is densely shaded with tall trees and is less conducive for aquatic plant growth (Figure 35b).

An increase in marginal vegetation would enhance the diversity of the ponds as well as protecting exposed banks from further erosion. Current efforts are being made by Zoo staff to deal with the erosion taking place at the flamingo enclosure. These include infilling eroded areas and planting willow saplings at the exposed edges of the pond (Plate 20b). Additional protection could be achieved by inserting staked willow bunches (or faggotts) 1 to 1.5m out from the water's edge, beyond the willow saplings (O' Grady, 2006). Bankside recolonisation might also be expedited by transplanting live rhizomes from a range of reed species into the pond margins (Caffrey & Beglin, 1996). Reedmace rhizomes from the Dog Pond in the Phoenix Park could be used to start this operation.

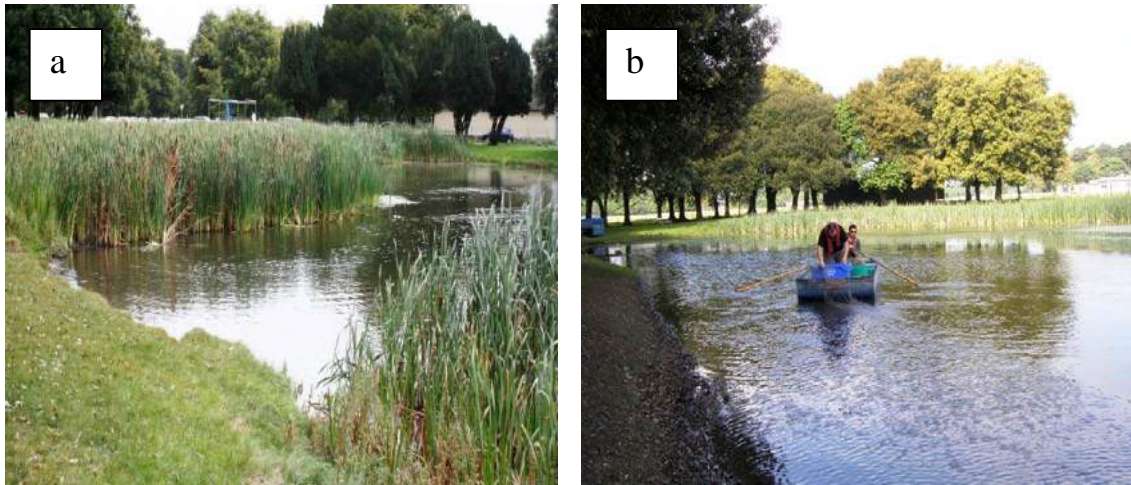
Plate 35. Views of the Dog Pond, Phoenix Park, showing a) marginal communities on northern shore and b) the extent of shading on southern shore (left foreground).

The shaded, silted areas that were covered with leaf litter (Plate 35b) were dominated by the bivalves *Sphaerium* sp. and *Pisidium* sp., together with juvenile Hydrobiidae and *Asellus aquaticus*.

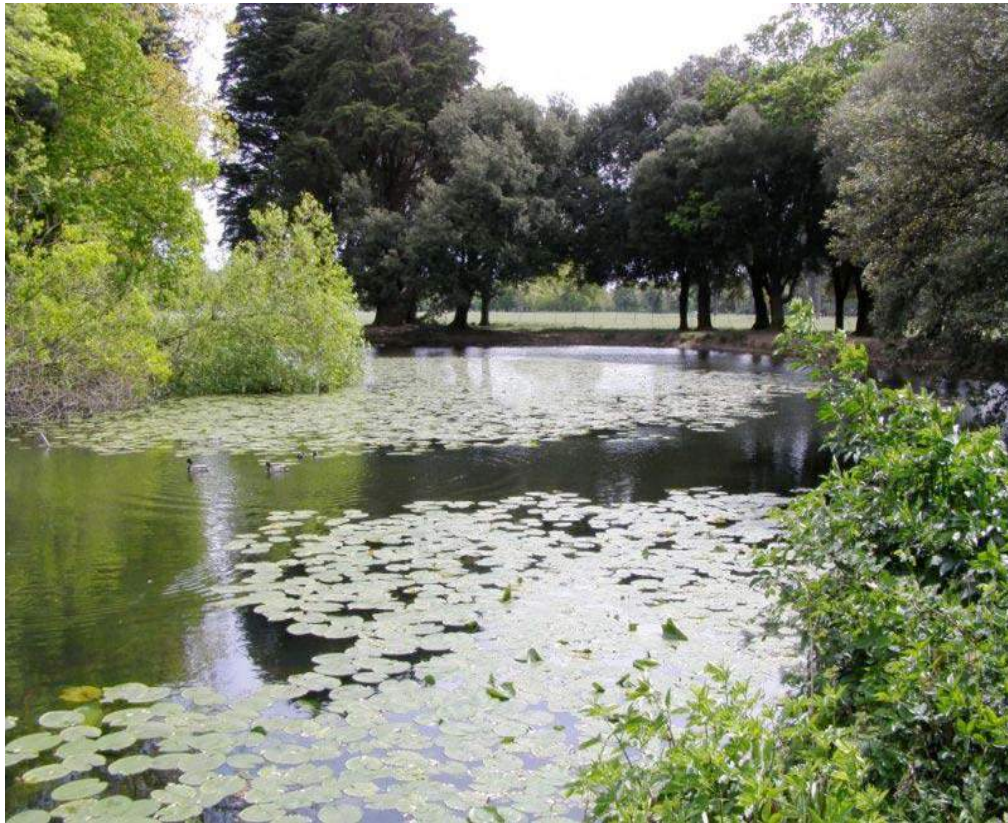
Plate 38. A view of the Island Pond, Phoenix Park, from the western end in June 2007. Large beds of Yellow water lily and a number of mallard are visible on the pond.

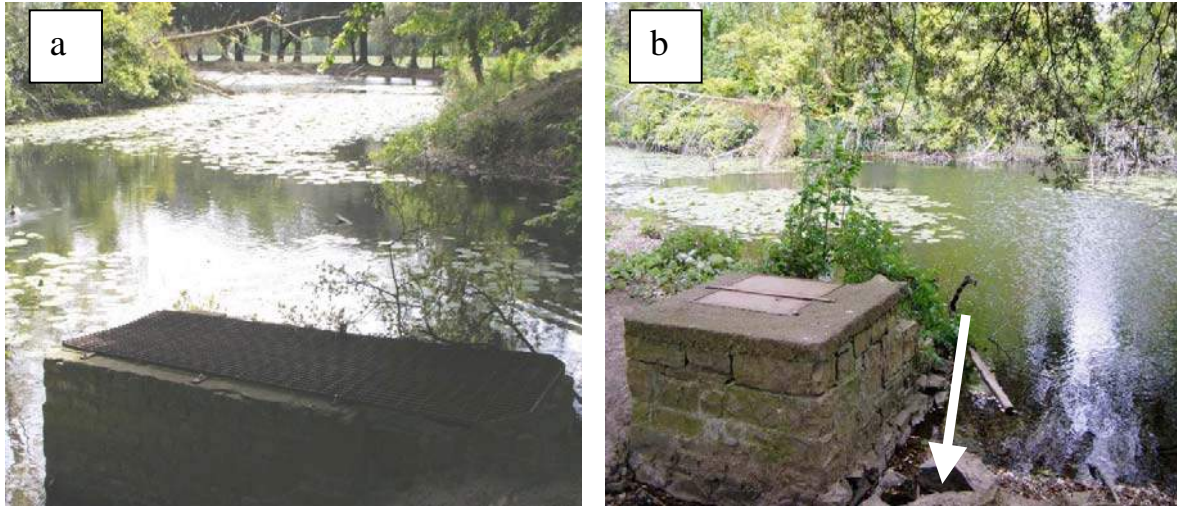
literature search shed light on the original water source. The Magazine Stream is located to the west of the pond (see Figure 1) and it is probable that this watercourse is the principal supply to the pond, particularly during times of high flow. Excess water in the pond is discharged through a brick-clad outflow and a dug trench on the south-western shore (Figure 24, Plate 39 b).

Plate 39. The Island Pond in the Phoenix Park showing a) the outflow and b) the inflow to the pond.

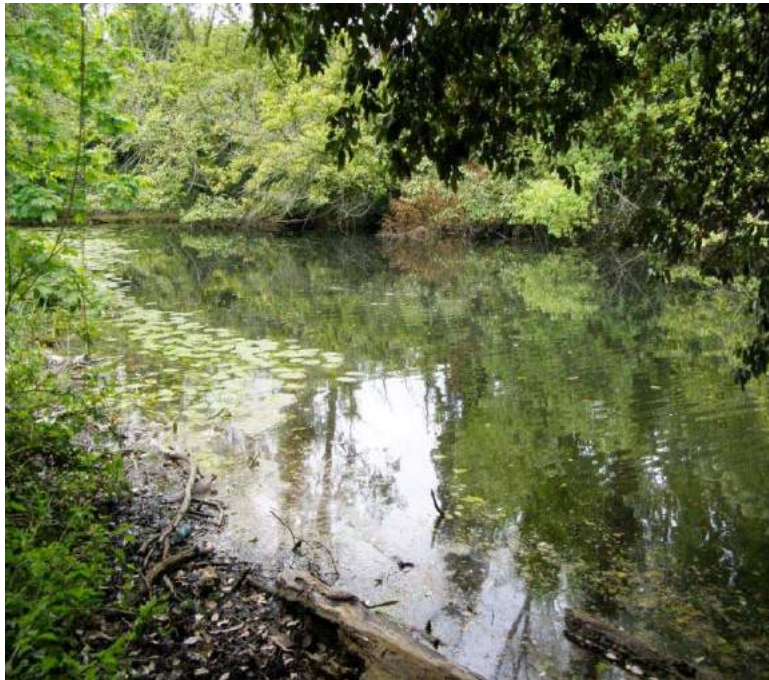
Plate 41. Tall overhanging vegetation casts a dense shade on the Island Pond in the Phoenix Park during a survey conducted in summer 2007.

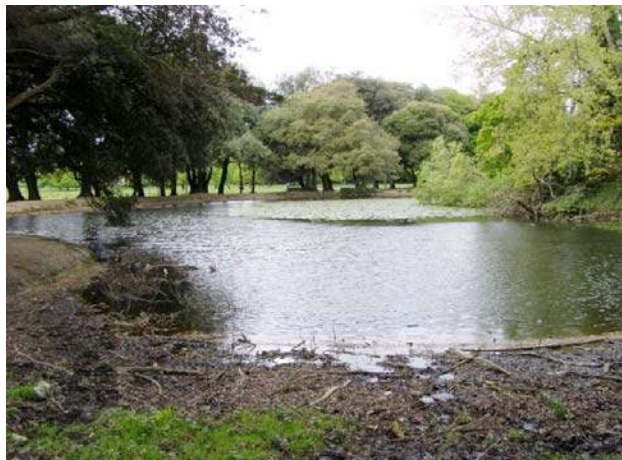
Plate 42. The impact of dense overhead shading is evident in the exposed margins that occupy much of the Island Pond in the Phoenix Park.

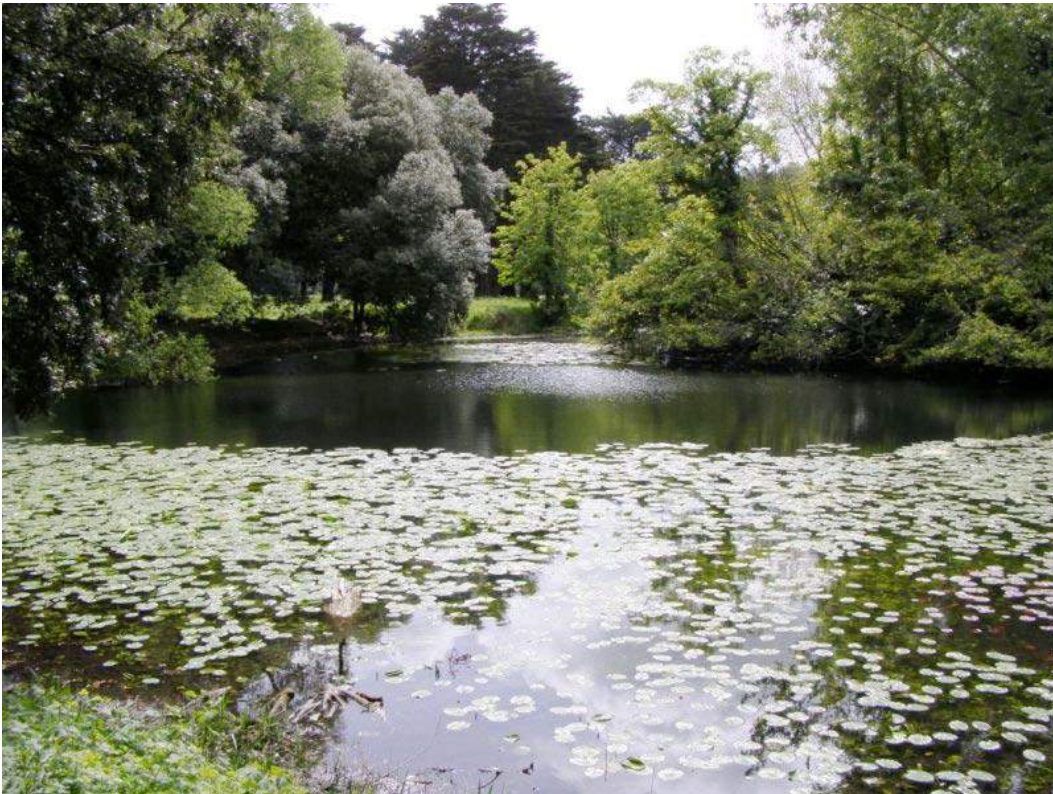
Beyond this sparse emergent vegetation zone, extensive stands of Yellow water-lily (*Nuphar lutea*) (Plate 43) were commonly present. This was the dominant macrophyte species in the Island Pond and occupied *circa* 30% cover of the open water during the summer of 2007. Two free-floating species, Common duckweed (*Lemna minor*) and Ivy-leaved duckweed (*L. trisulca*), were also recorded, although with considerably less abundance. The *L. trisulca* remained submerged and formed thin vegetation mats on the decaying leaf litter.

Plate 43. Beds of Yellow water lily (*Nuphar lutea*) in the northern section of the Island Pond, Phoenix Park, in 2007
