PONDS of the PHOENIX PARK

Current Ecological Status and Future Management

Caffrey, J.M., Coyne, J. & Gallagher, T.

February 2008

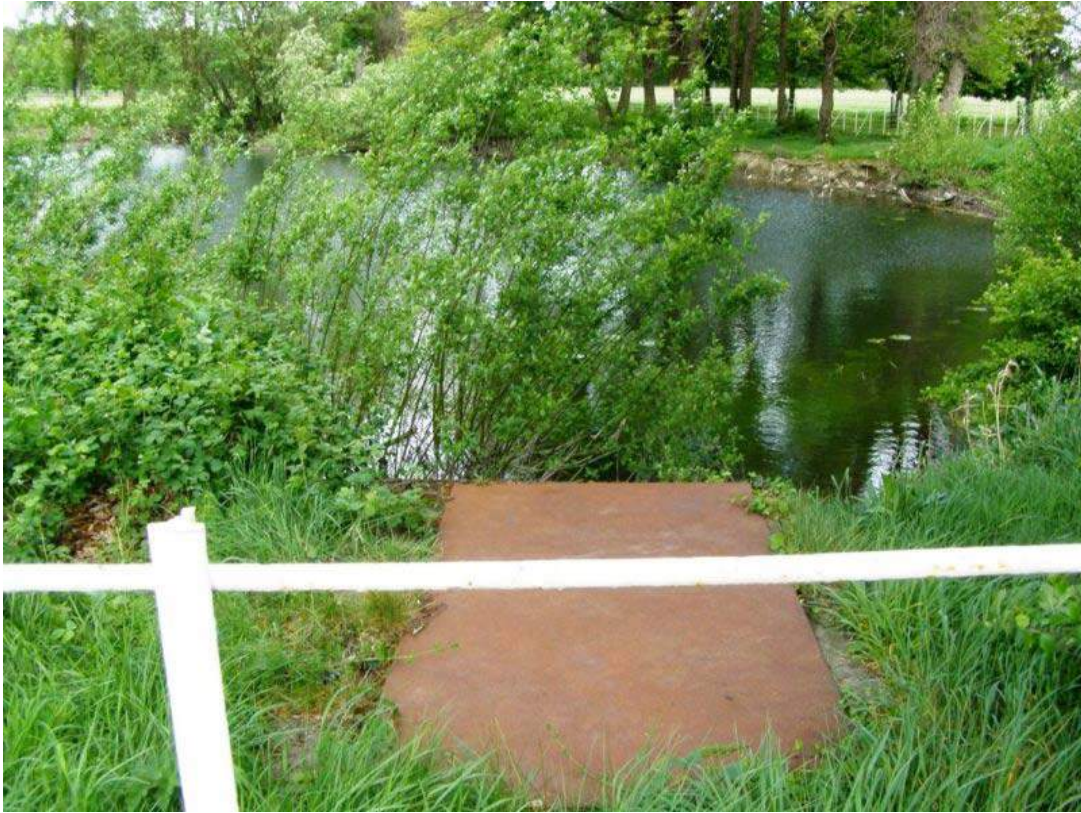
The culverted Viceregal Stream runs alongside the Machine Pond *en route* to the Áras Pond and the Dublin Zoo complex, before draining into the River Liffey. The pond has an inflow and outflow on its north-western and south-western shores, respectively (Plate 46 & Figure 29). While there is no information available on the water supply to the pond, the alignment of the inflow and outflow corresponds to the Viceregal Stream, suggesting it is an off-line pond supplied by this stream. During the survey period, the flow of water from the inflow was negligible. The stream probably acts as an intermittent source of water, depending on rainfall.

Plate 46. Outflow from the Machine Pond, Phoenix Park.

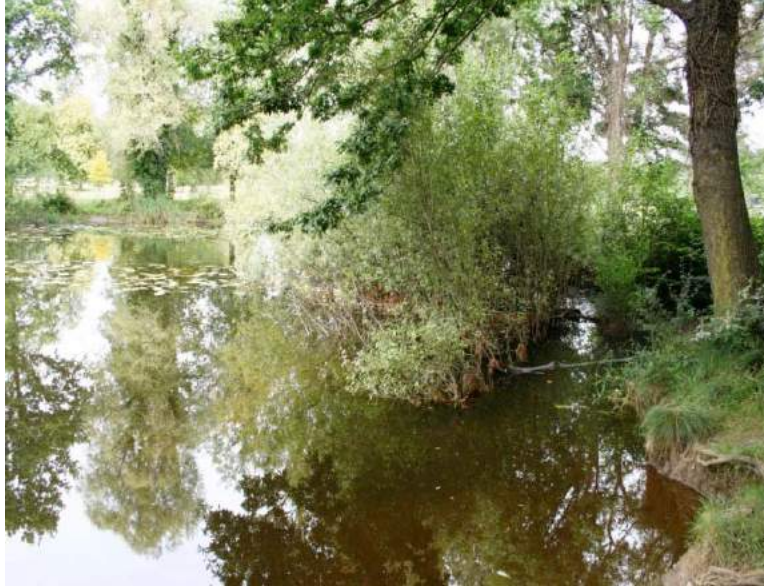
Water levels in the Machine Pond varied considerably during the survey period. In June 2007, following a prolonged period of heavy rainfall, high water prevailed and a maximum water depth of 4m was recorded (Figure 27 & Plate 48). By October 2007 the water level had dropped approximately 0.6m, exposing large areas of bare bank (Plate 49).

Plate 48. High water levels prevailed in the Machine Pond, in June 2007, following heavy rainfall.

This level of water fluctuation was not observed in any of the other ponds in the Phoenix Park in 2007. It suggests a significant influx of water during periods of high rainfall, although the exact source has not been determined.

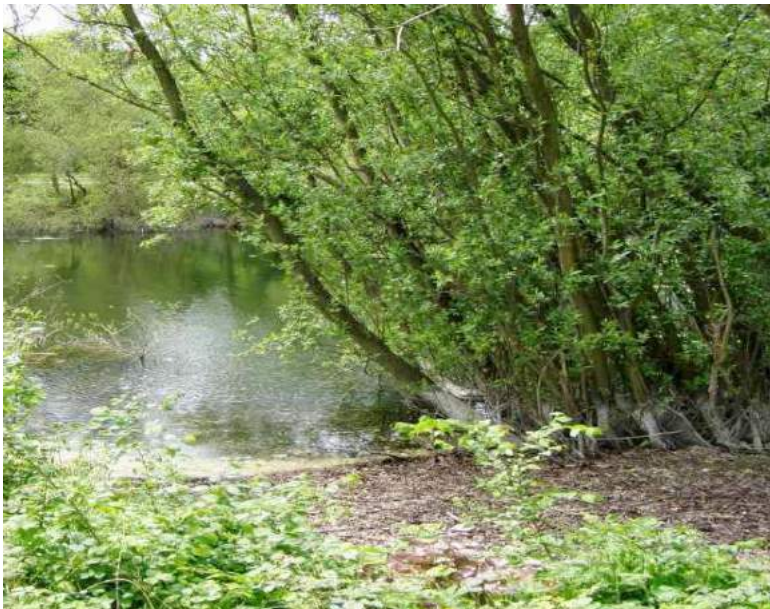
Plate 49. Areas of bare bank exposed by dropping water levels in October 2007 in the Machine Pond, Phoenix Park.

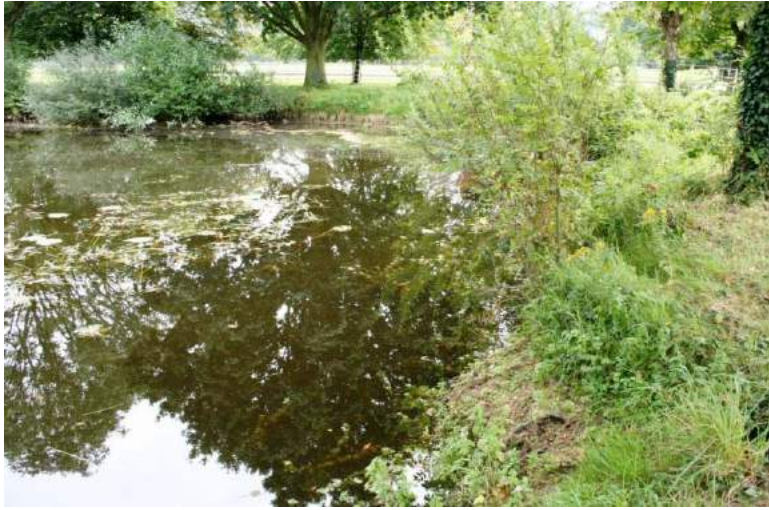
Tall, deciduous trees, mainly willow (*Salix* spp.) grew around the perimeter of the Machine Pond, casting a dappling, rather than a dense shade on the water. In places, relatively low-growing and ‘bushy’ willows encroached up to 5m into the water (Plates

47 to 50). The marginal aquatic flora was relatively restricted by the more aggressive willows and occupies only localised bankside areas. The principal emergent species was

Plate 50. Marginal and emergent plant communities in the Machine Pond, Phoenix Park, in June 2007.

Reed canary grass (*Phalaris arundinacea*), which occupied less than 10% of the pond margins. The fringing herb Water mint (*Mentha aquatica*) occupied occasional dense vegetation stands, some of which were completely submerged and others of which produced floating carpets that were anchored to the margins. Both growth forms are commonly encountered in Irish aquatic habitats.

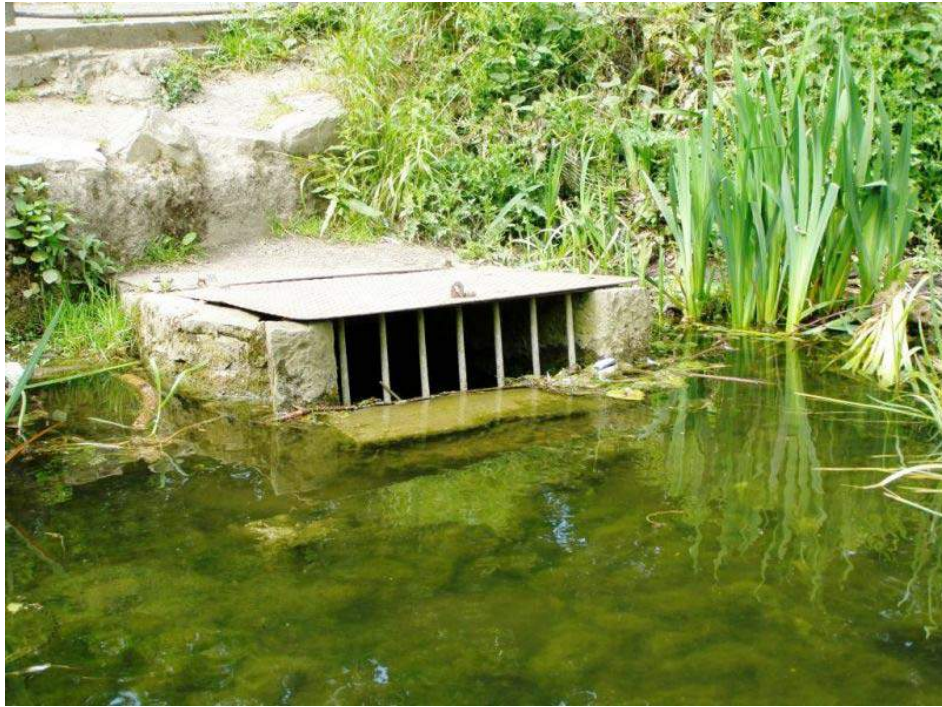
Plate 52. Outflow from Glen Pond, Phoenix Park

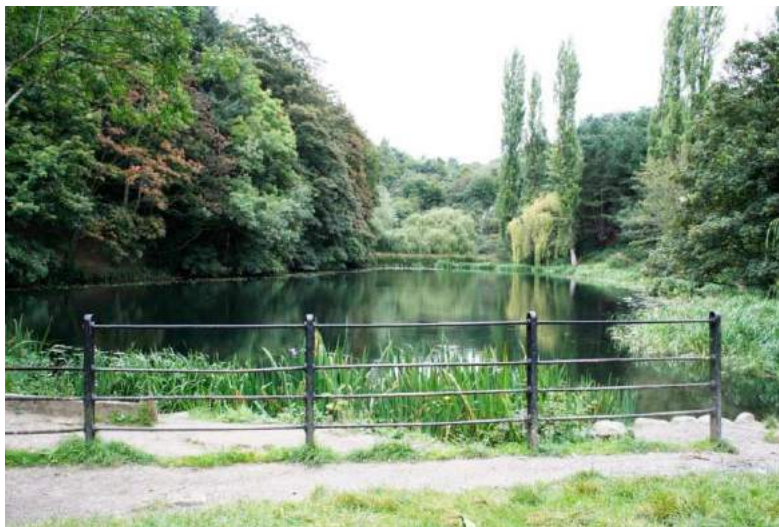
At approximately 0.38 hectares, the Glen Pond is one of the larger ponds in the Phoenix Park system. It is encircled by mature deciduous trees and a path runs along its eastern edge (Figure 31). At one point in time, the pond may have been surrounded by a cast iron railing, as remnants are still visible along the eastern bank and a section of railing is still intact along the southern shore (Plate 53). The pond is close to a series of paths and roads, although the main access road is not available to public vehicles. The southern end of the pond, where the outflow is located, is dammed to accommodate the access road.

Plate 53. View of the Glen Pond, Phoenix Park, from the southern bank, showing the remnant of the metal railing.

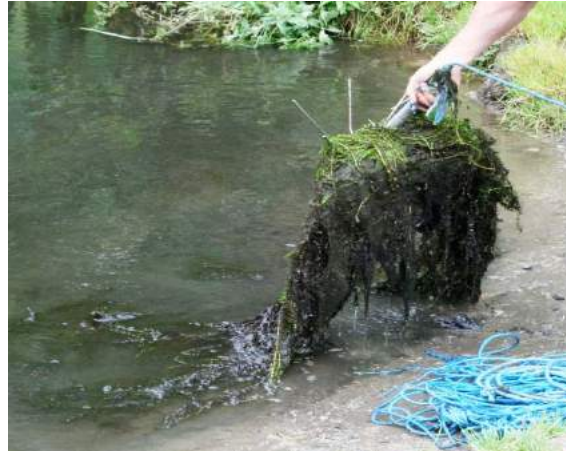
Plate 55. Grapnel haul showing an abundant submerged flora in the Glen Pond, Phoenix Park, during summer 2007.

The submerged macrophyte flora was dominated by two species, the rooted Canadian pondweed (*Elodea canadensis*) and the free-floating Blanketweed (*Cladophora* sp. (cf. *glomerata*) (Plate 55). Other filamentous algae were also present, but with less abundance than *Cladophora*. Most prominent among these, particularly close to the inflow, was *Spirogyra intestinalis*. Both *Elodea* and *Cladophora* are pollution tolerant species and

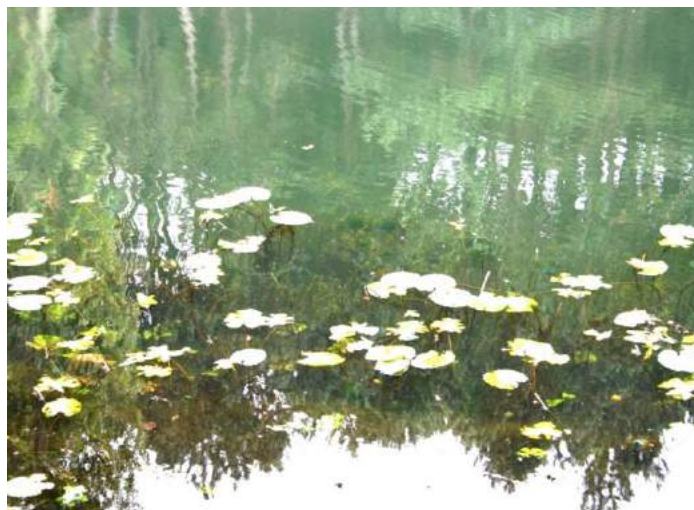
both can grow in shaded situations. Their prominence in the Glen Pond, therefore, is not unexpected. Dense stands of *Elodea* formed a reasonably distinct vegetation band around the lake margins, often occupying the zone beneath and beyond the floating leaves of *N. lutea* (Plate 57).

Plate 57. Large band of *Elodea canadensis* is present beneath and outside the band of *Nuphar lutea* along the margins of the Glen Pond, Phoenix Park, in 2007.

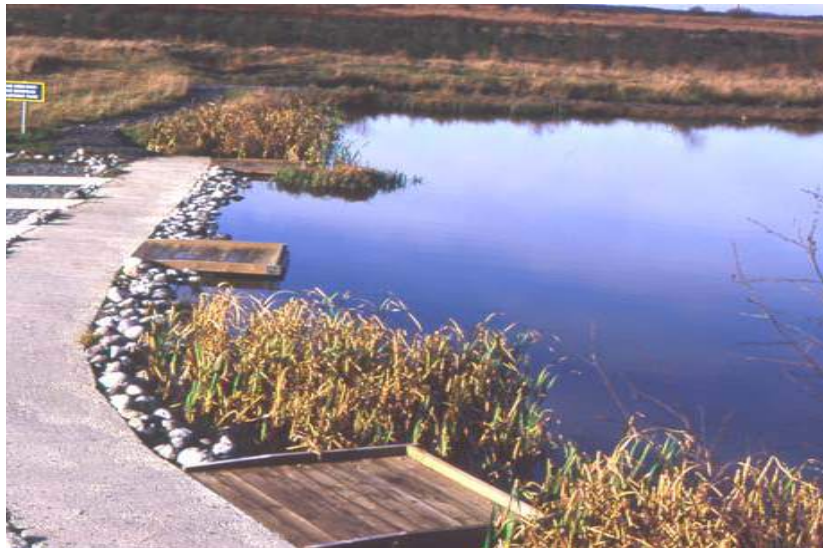
Plate 61. Fishing stands on an artificial pond in Co. Offaly.

It is recommended that the pond is stocked with carp, tench and rudd to augment the fish populations already present in the pond. The general public already use the Glen Pond as an angling resource and the instalment of fishing stands (e.g. Plate 61) would provide a structural incentive, as well as protecting underlying banks.

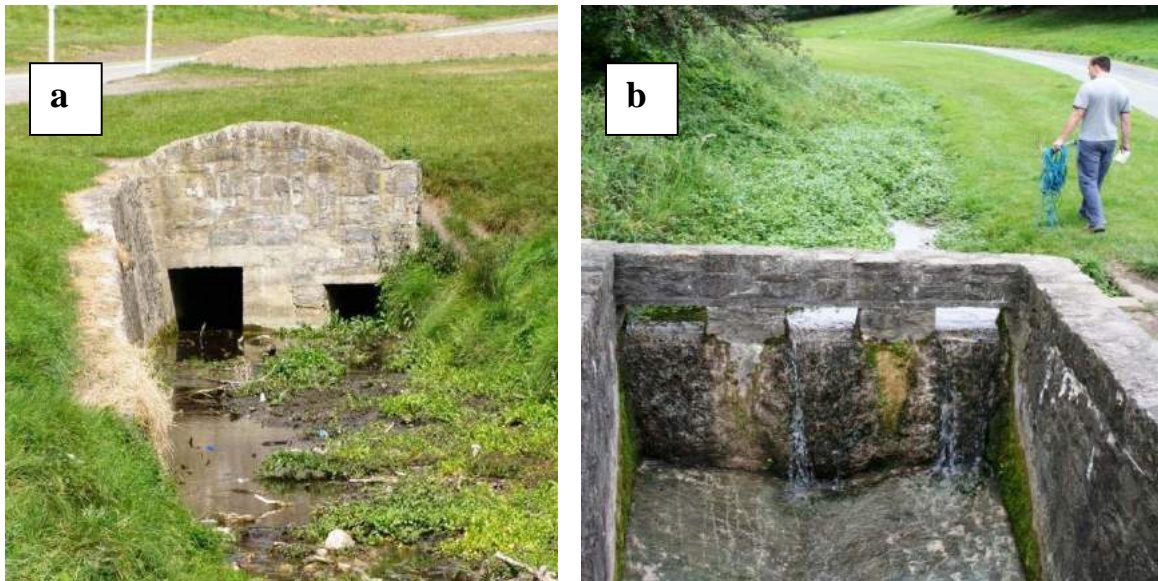
Plate 64. The Magazine stream within the Phoenix Park a) where it emerges from an underground culvert and b) at the site of a concrete weir.

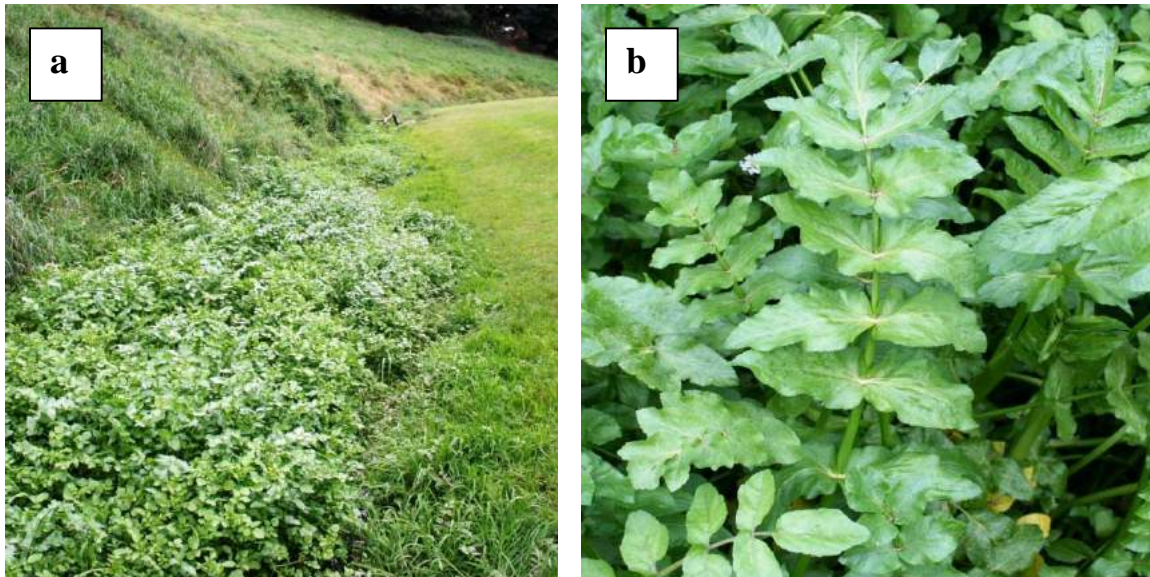
Plate 65. The Magazine Stream in the Phoenix Park, showing a) significant encroachment with emergent vegetation, and b) some of the species involved (*Apium nodiflorum*, with *Nasturtium aquaticum* in the foreground).
