# Ashtown Castle

## VISITORS' GUIDE

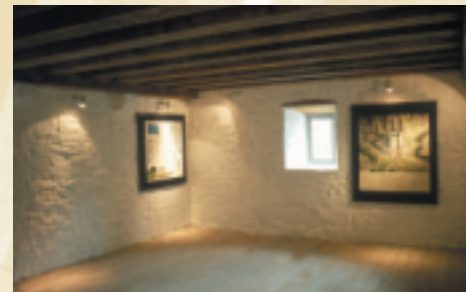
Interior Ashtown Castle

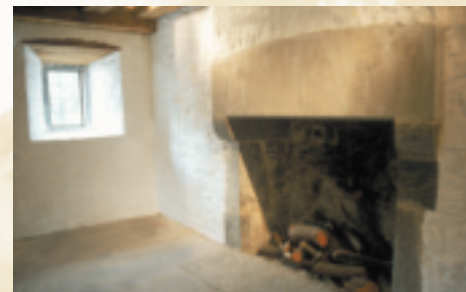
Fireplace in Ashtown Castle

This contained one of the principal living chambers of the tower. Access from the stair is through a round arched doorway with dressed stone jambs. Along with the main doorway, this is one of a set at each of the four floors. The chamber is well lit and was warmed by a plain finely crafted fireplace. The chamber could be partitioned or screened as needs required to provide space for living and managing the household and farm, as well as lodgings.

Secure, high above the ground, elegant twin-light windows light the “great chamber”. In the gable walls are plain single opes. The fireplace was reconstructed to the design of the surround on the first floor. Above the “great chamber” and partly in the roof space of the tower was a “garret” or attic. This is now partly floored and reconstructed as a gallery. This space is lit only by a single loop in the eastern gable and is unheated. The use of the roof space varied in tower houses and was adapted to many uses such as a place of safety or lodging. As a gallery, it enhanced the grandeur of the great chamber.

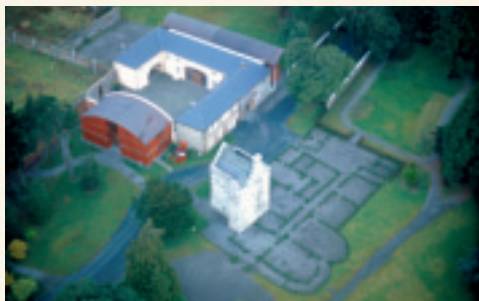
Background: Oak Roof Truss

Restoration works on Ashtown Castle started in the autumn of 1989 when a survey of the structure and the removal of the modern plaster began to reveal clues to the original form of the castle. The alterations of the 18th and 19th centuries had included the insertion of Georgian windows, new floors and the replacement of part of the roof. The discovery of the remains of a roof truss in the east gable provided a historical date for the roofing of

the castle using the process known as dendrochronology or tree-ring analysis. This showed that the oak used in the construction of the roof truss was felled in the early years of the 17th century.

The stair tower extends above the roof level giving access to the wall walks. The battlements were removed during the building of Ashtown Lodge. These have now been reconstructed without the crenellations of the 15th century or the decorative curvilinear parapet popular in the 17th century. The roof frame is based on the fragments of the truss discovered during the conservation work. The original gables survived and the chimney was modelled on existing examples in 17th century houses.

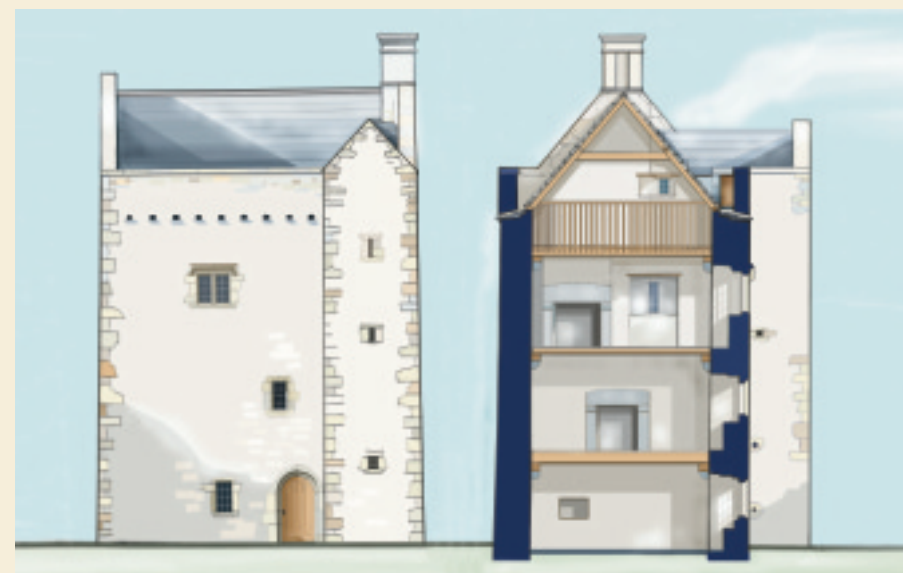
South Elevation

Section
